Collision Industry Conference

Write-It-Right Committee

Aluminum Rail Replacement on a 2004 and Newer 5 Series BMW

Replacing a Boron Steel Panel

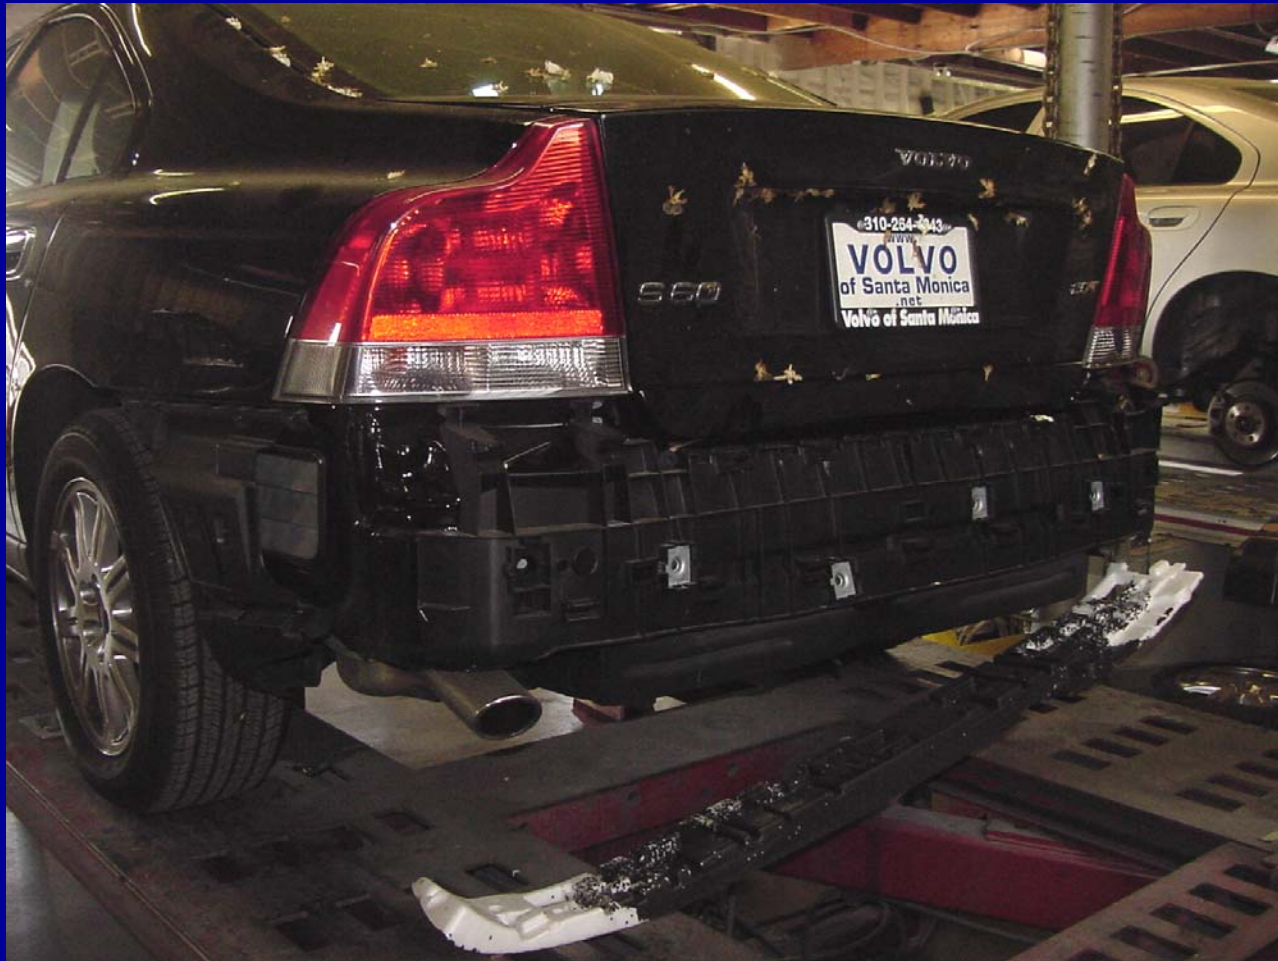
A LATE MODEL VOLVO WITH DAMAGE TO THE REAR PORTION OF THE VEHICLE.

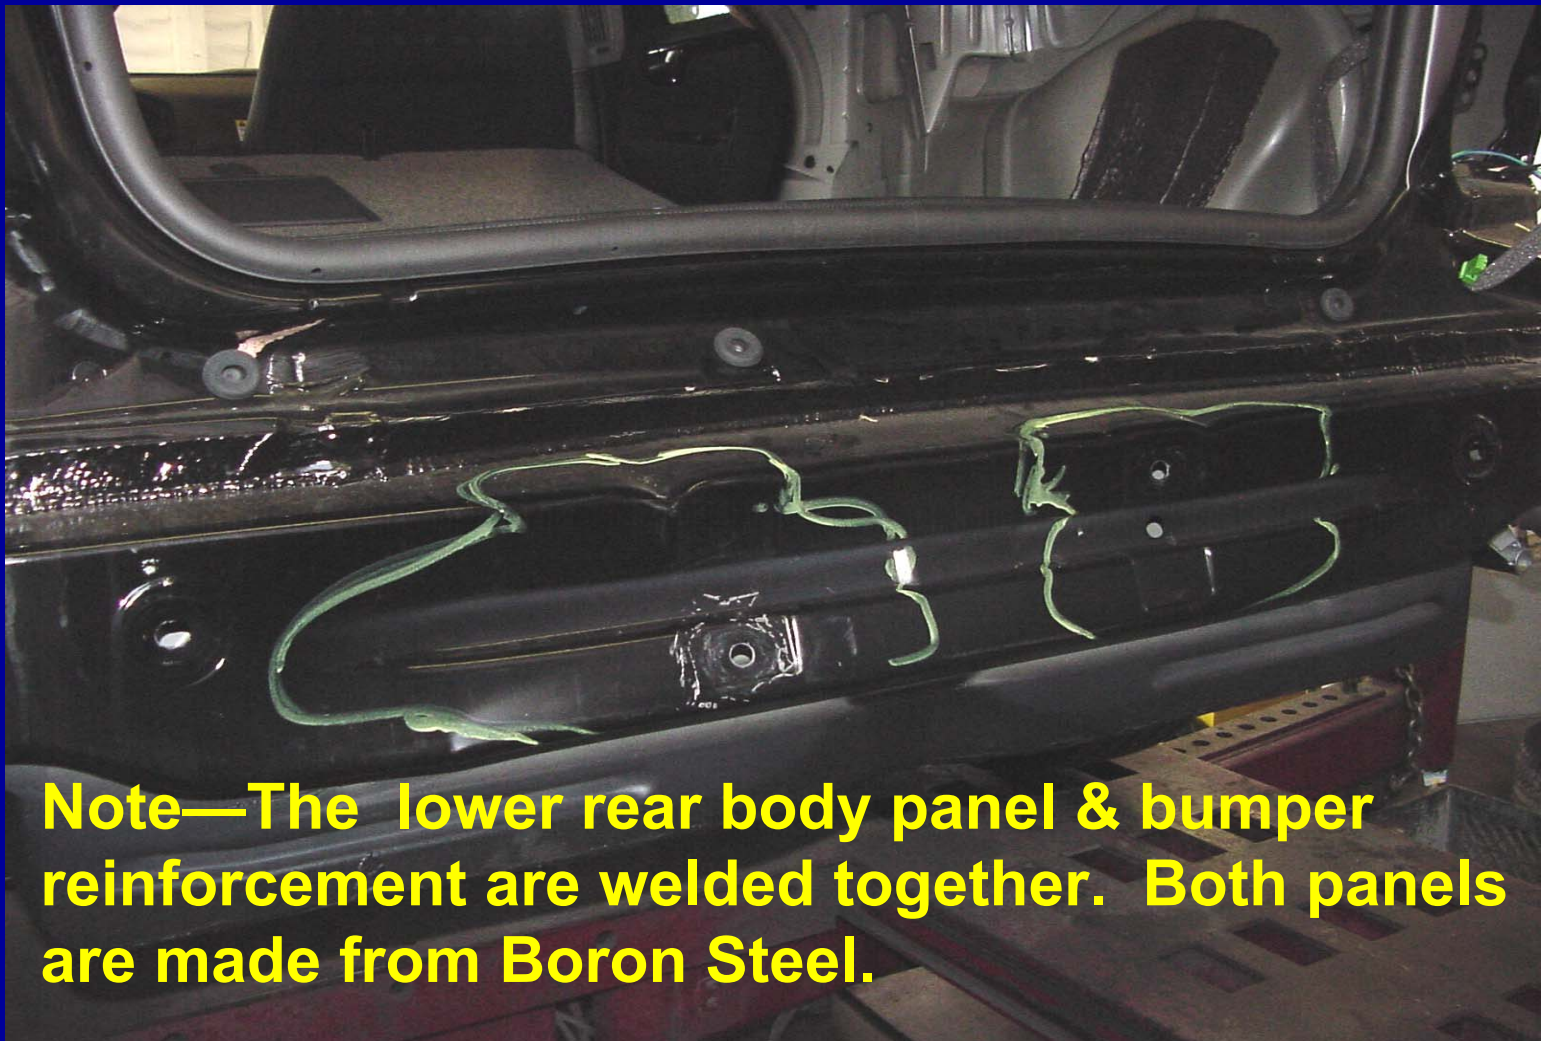
Damage to Boron Steel rear bumper reinforcement- lower rear body panel.

Note—The lower rear body panel & bumper reinforcement are welded together. Both panels are made from Boron Steel.

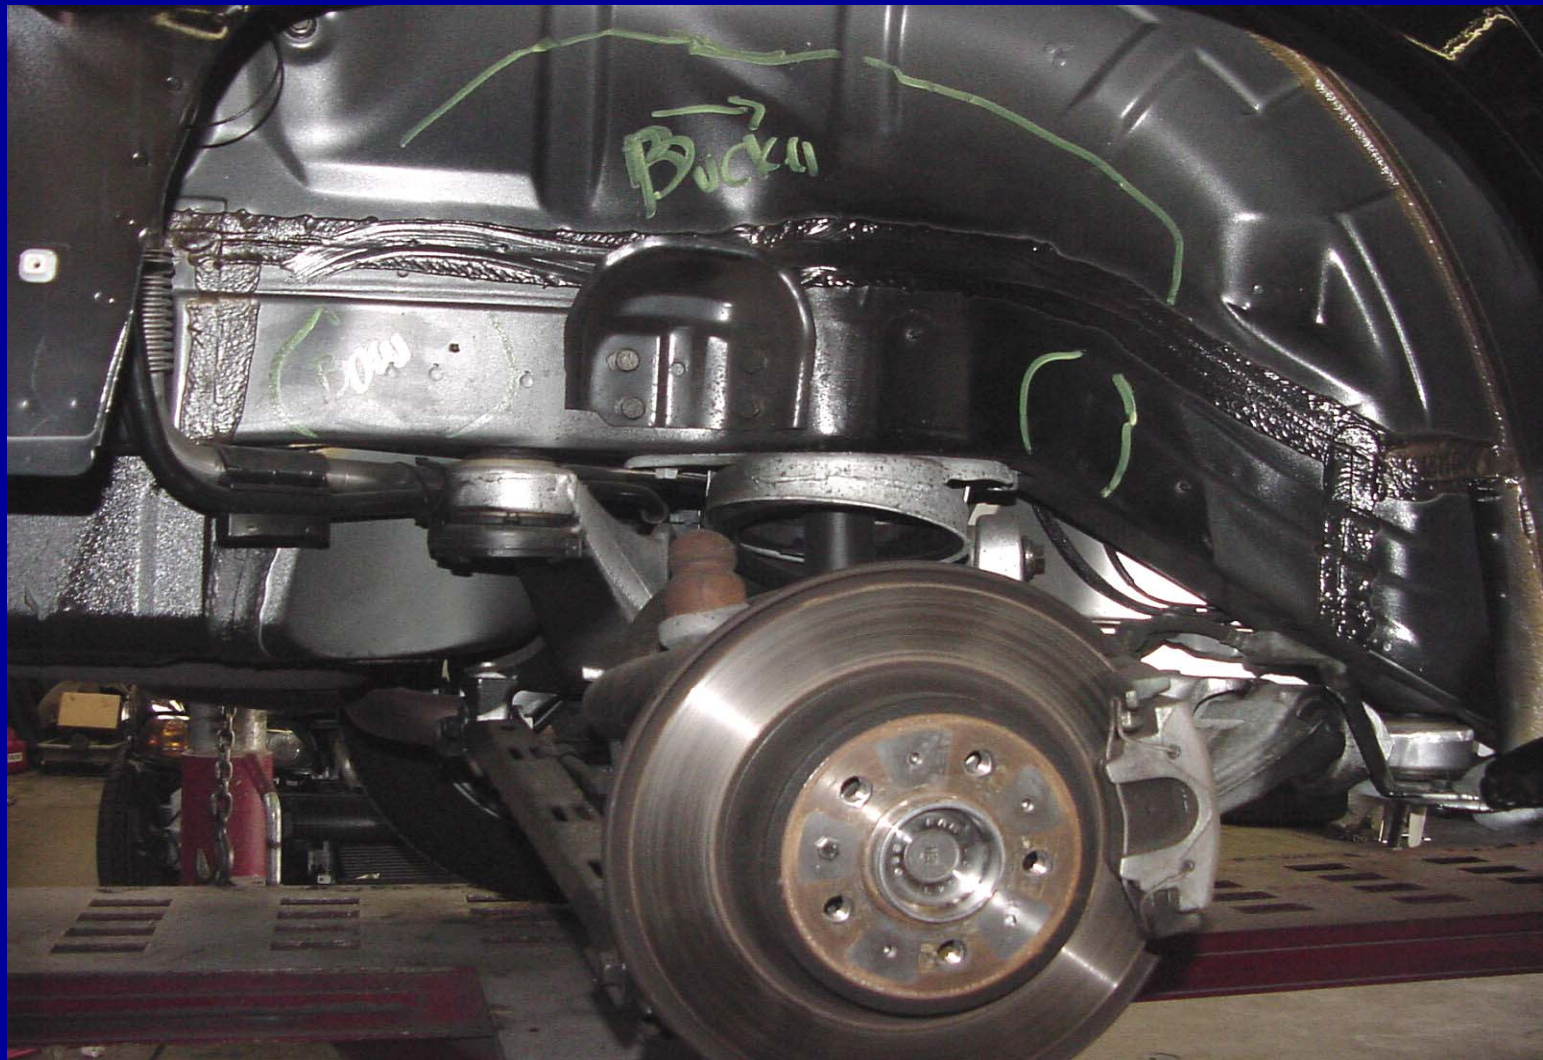
Damage to the inner rear quarter panel.

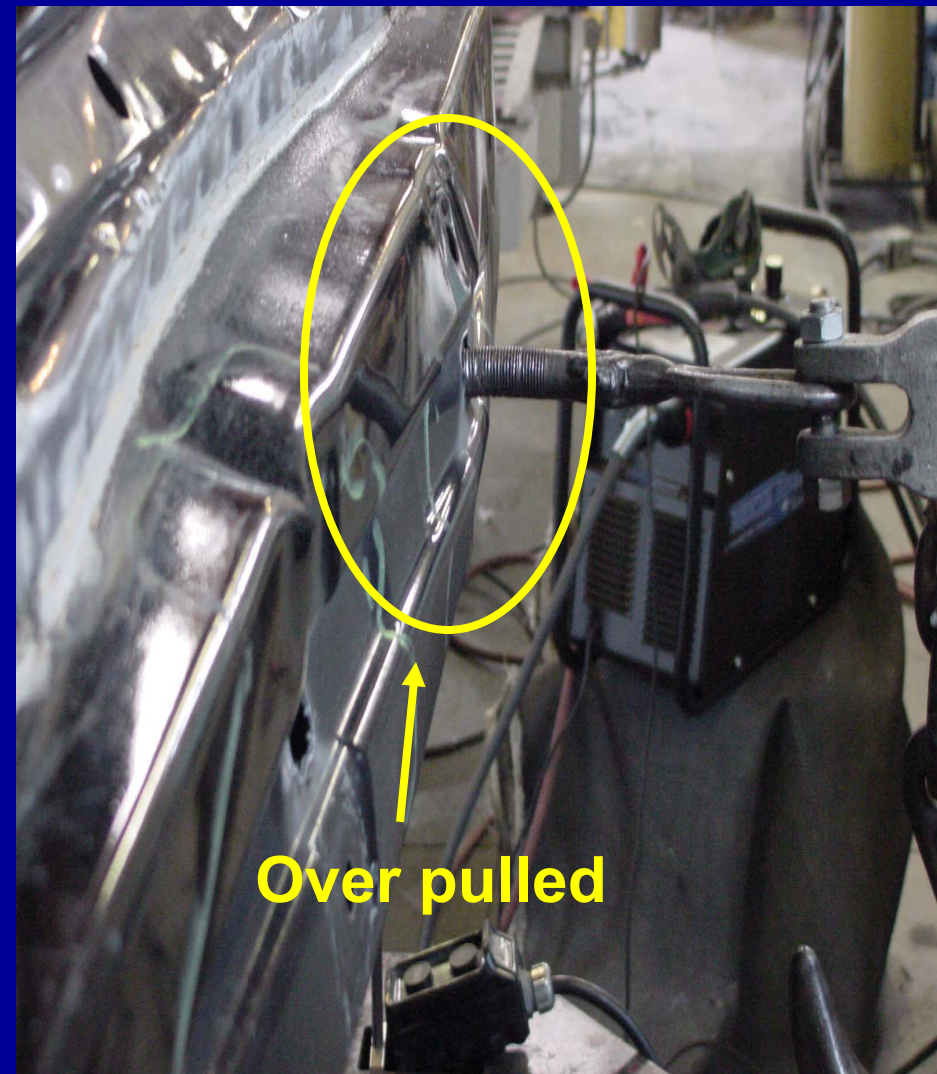
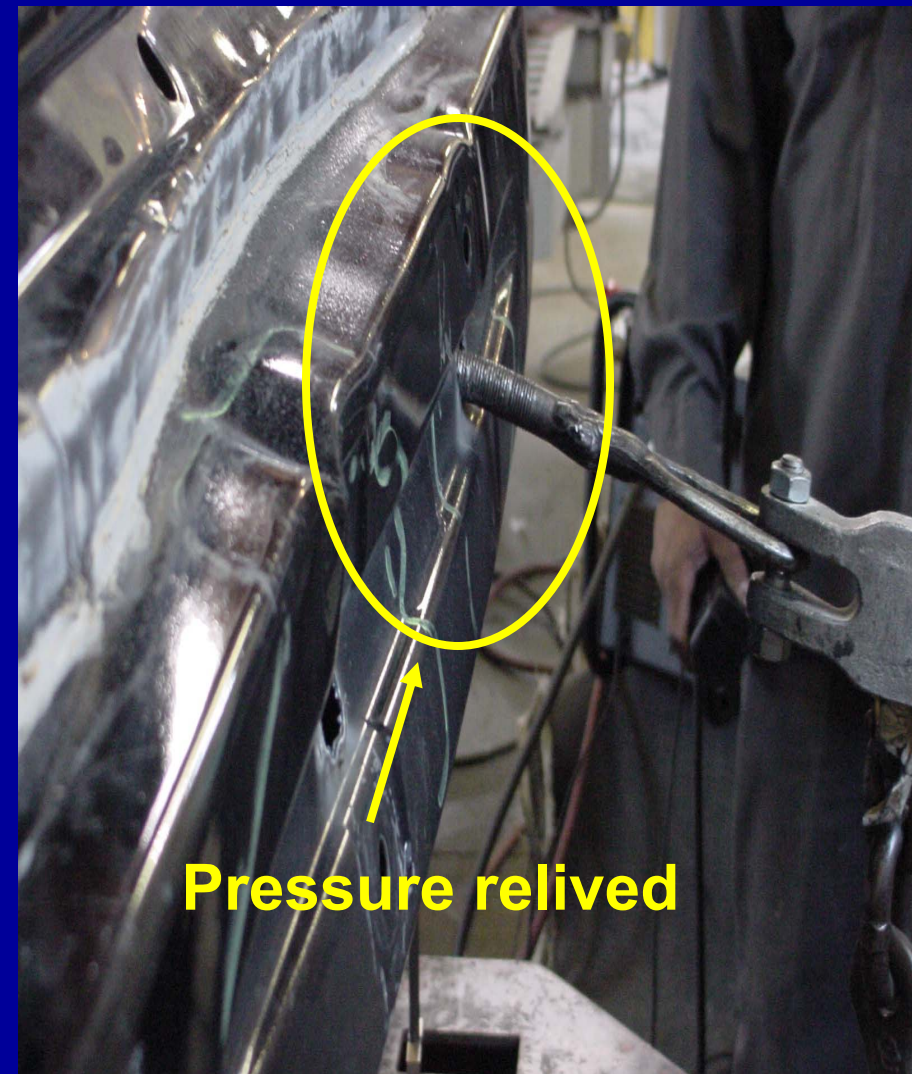
Note how bumper reinforcement is over pulled but returns to its original damaged state after the pressure is relieved.

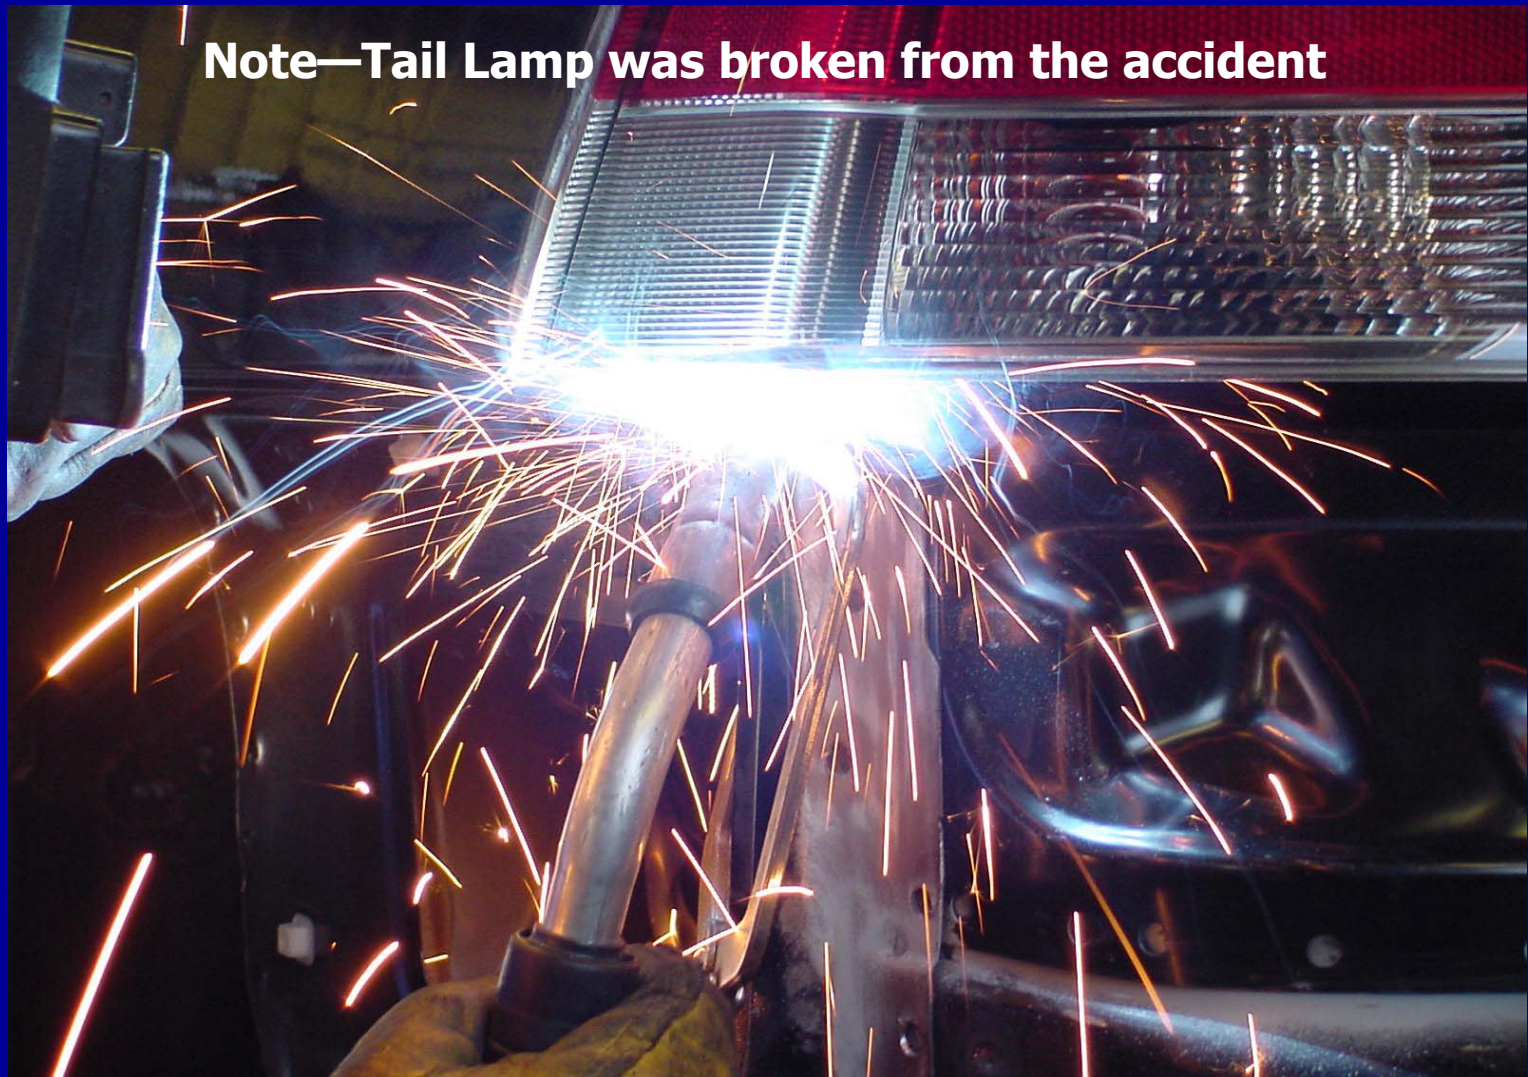
Note—Tail Lamp was broken from the accident

Finish welding the remaining panels.
