Volvo Car Customer Service TJ Instruction VCC-376947-56

Title	Safety instructions for rescue work	Page	1 (6)
Action	General safety information	Operation number:

Model year	Model	Engine	Partner group
2017, 2018	V90 (17-)	B4204T35	Europe
			International
			Nordic

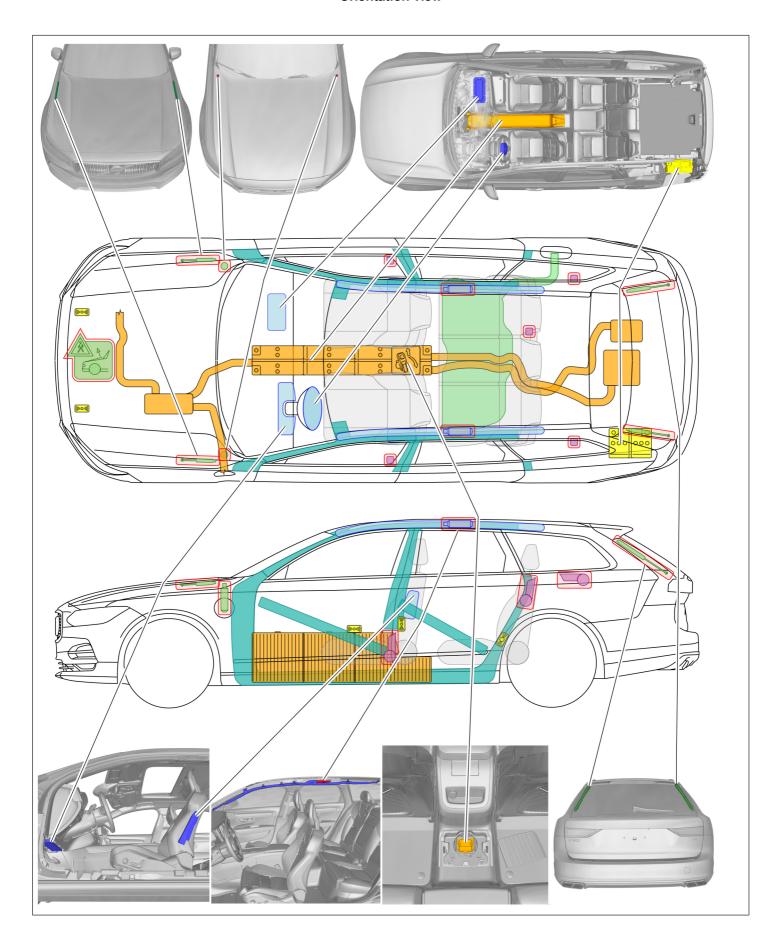
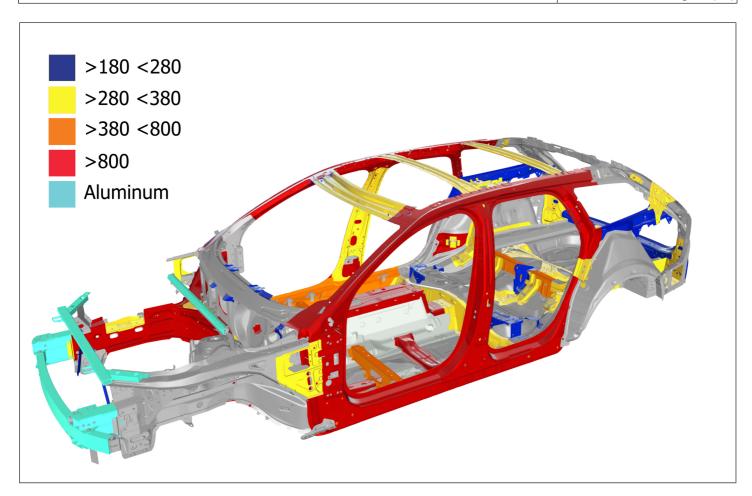
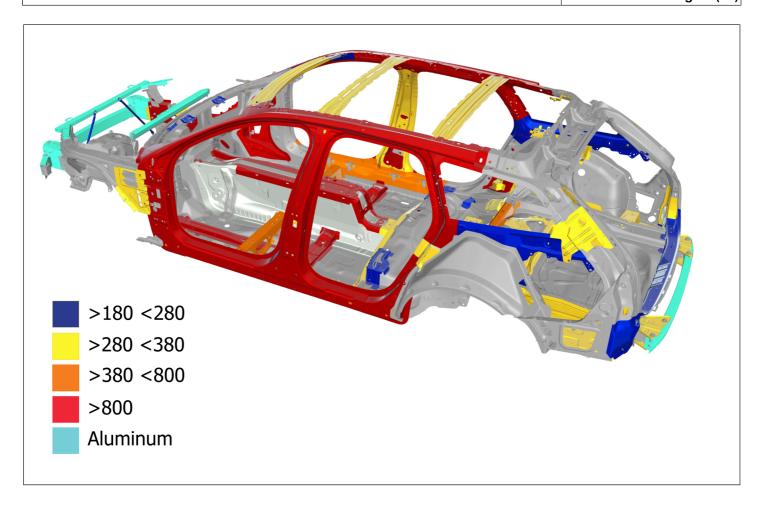
Orientation view

- 1 . Airbags
- 2 . Danger zone
- 3 . Seat belt pretensioner
- 4 . Reinforcements
- 5 . Fuel
- 6 . Battery
- 7 . High voltage
