Collision Industry Conference

Write-It-Right Committee

Aluminum Rail Replacement on a 2004 and Newer 5 Series BMW

Replacing a Boron Steel Panel

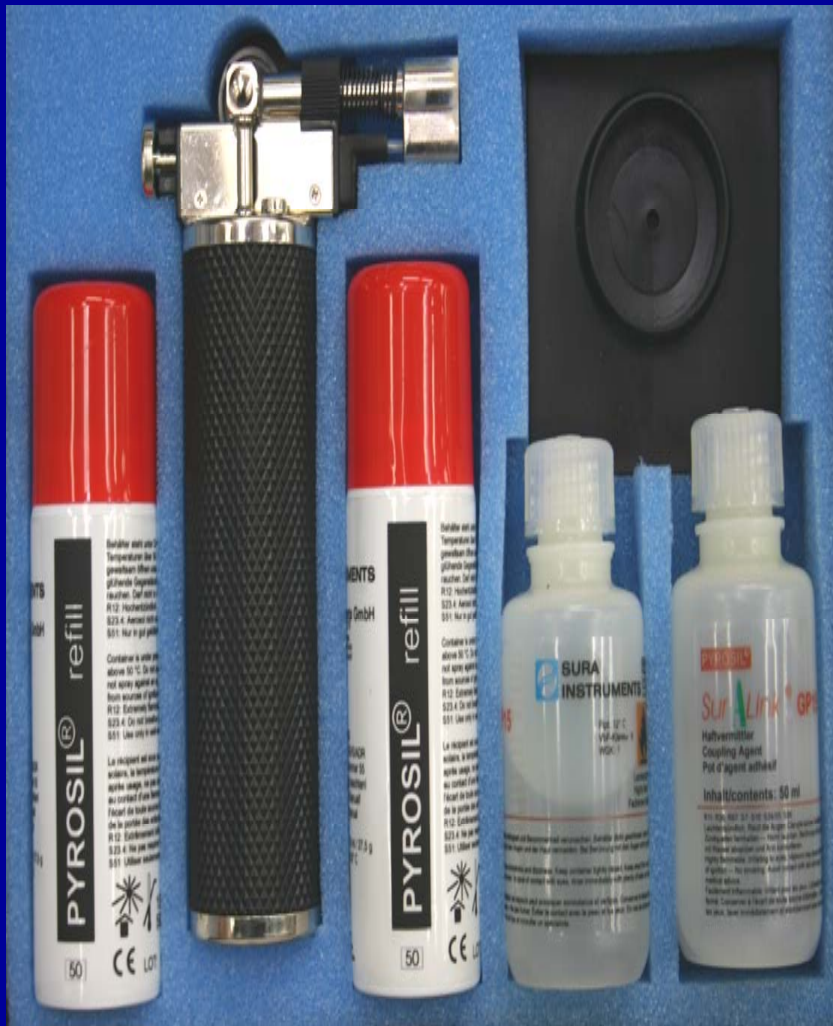
Pyrosil kit and Flame-coating of the replacement part prior to adhesive application.

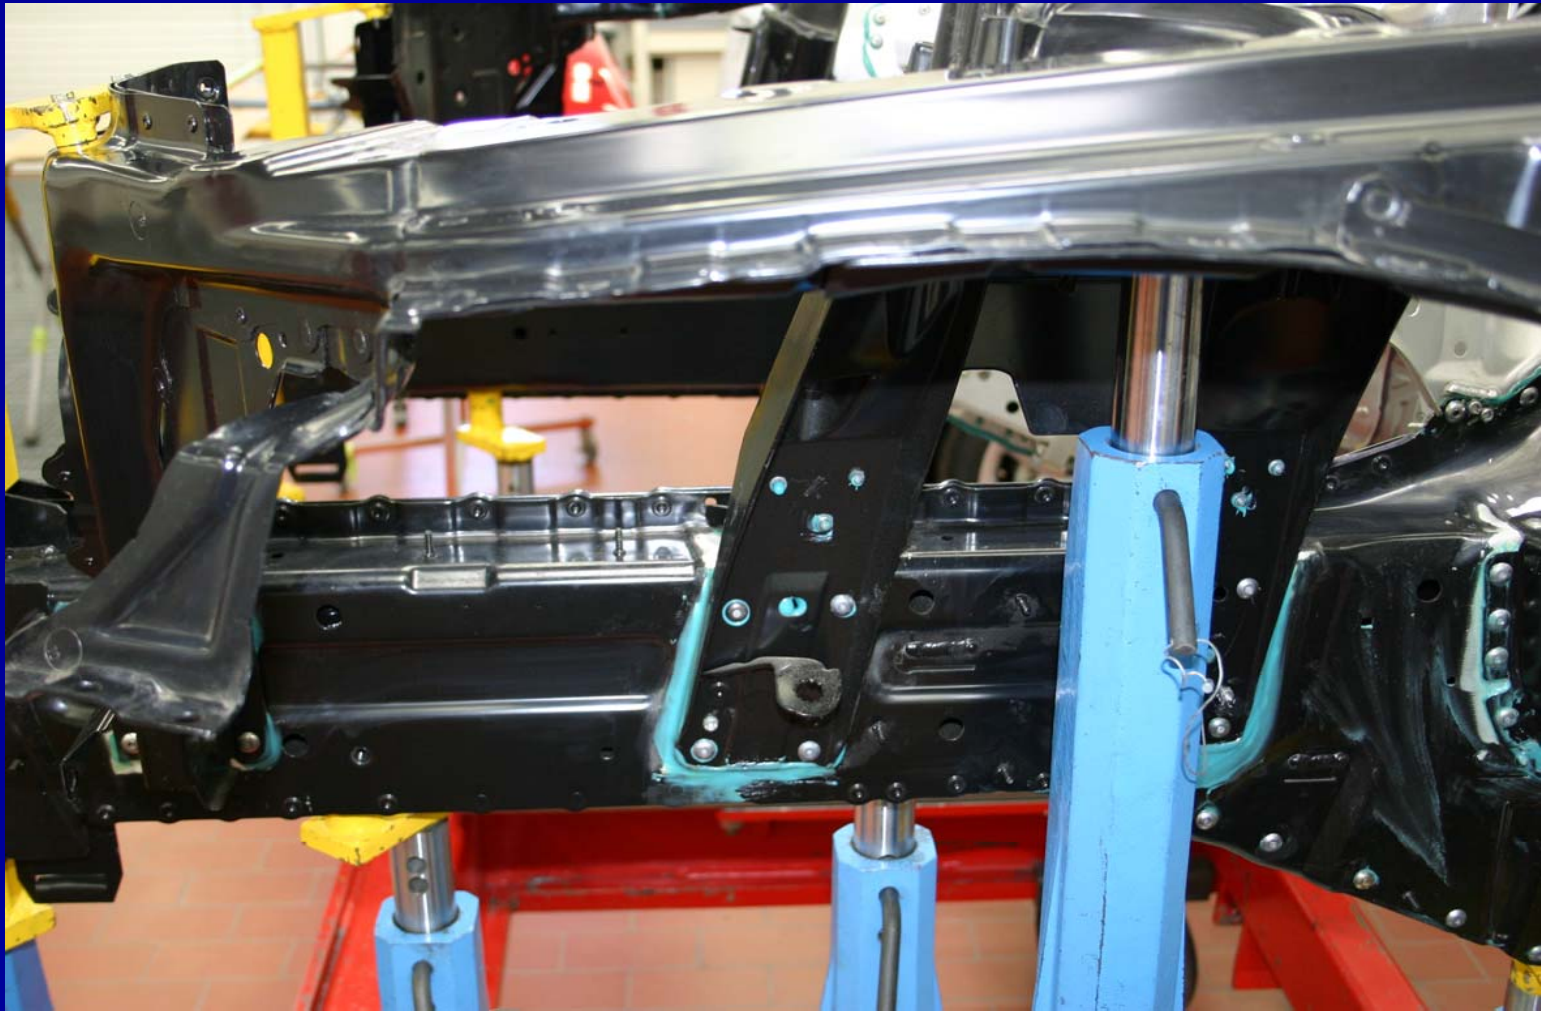
This photo is of a replacement of full rail and upper rail section.

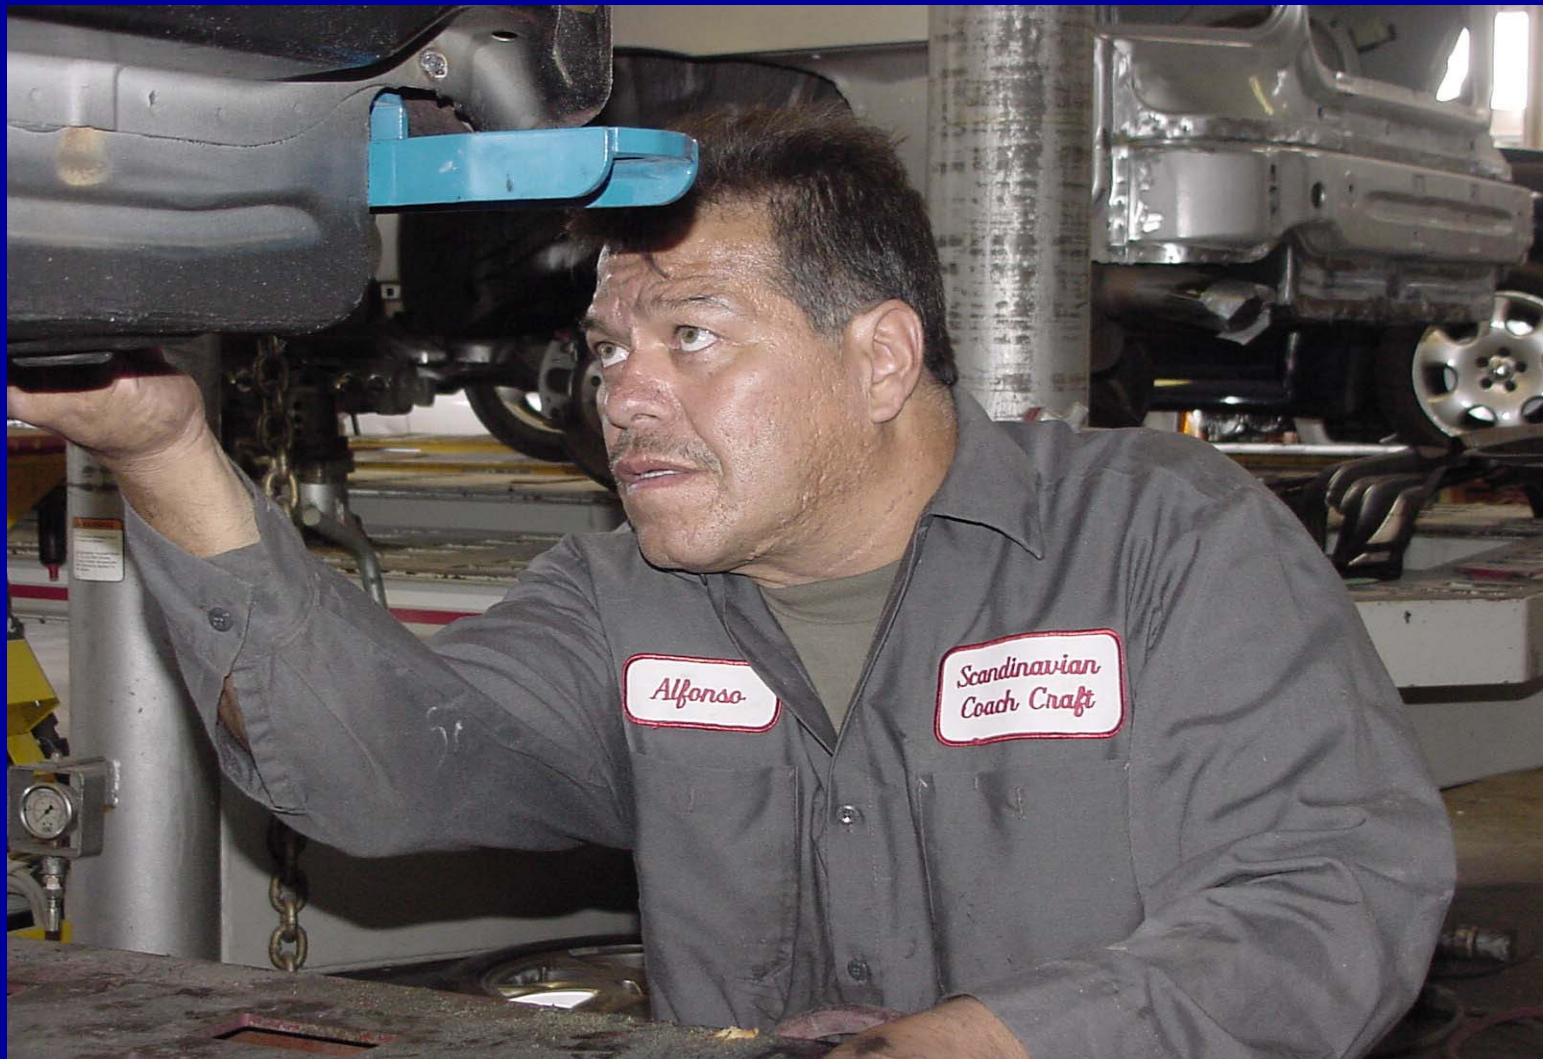
Install Volvo specific tool for pulling rear frame rail.

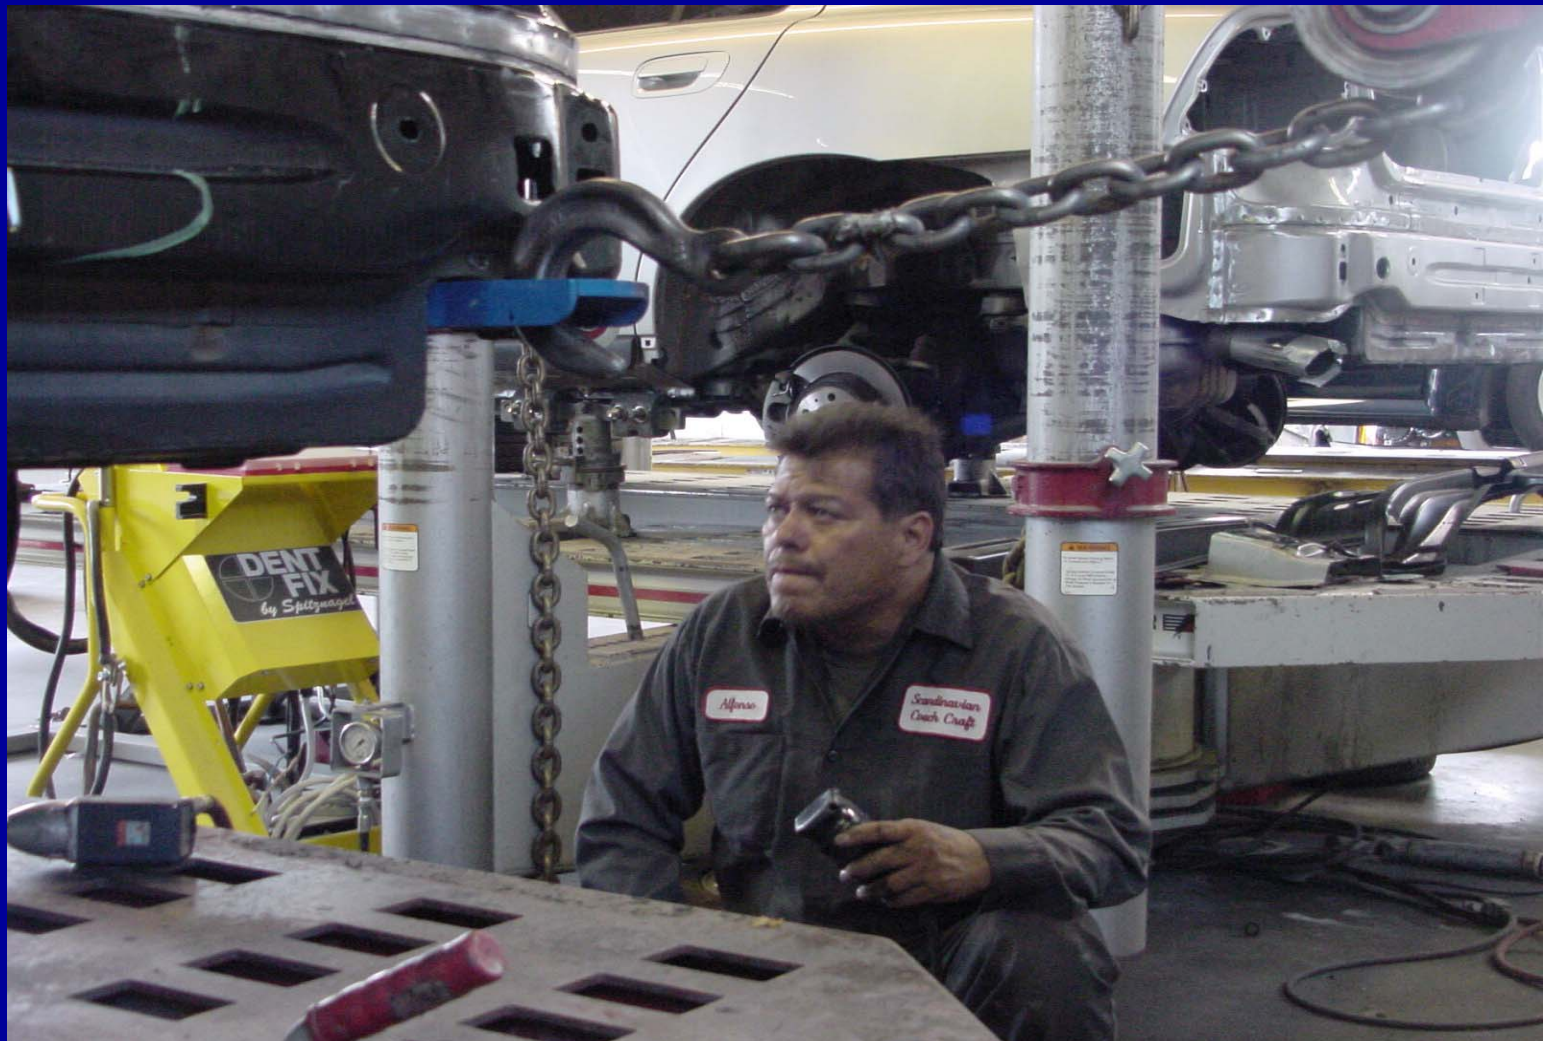
Pull vehicle to pre-loss dimensions

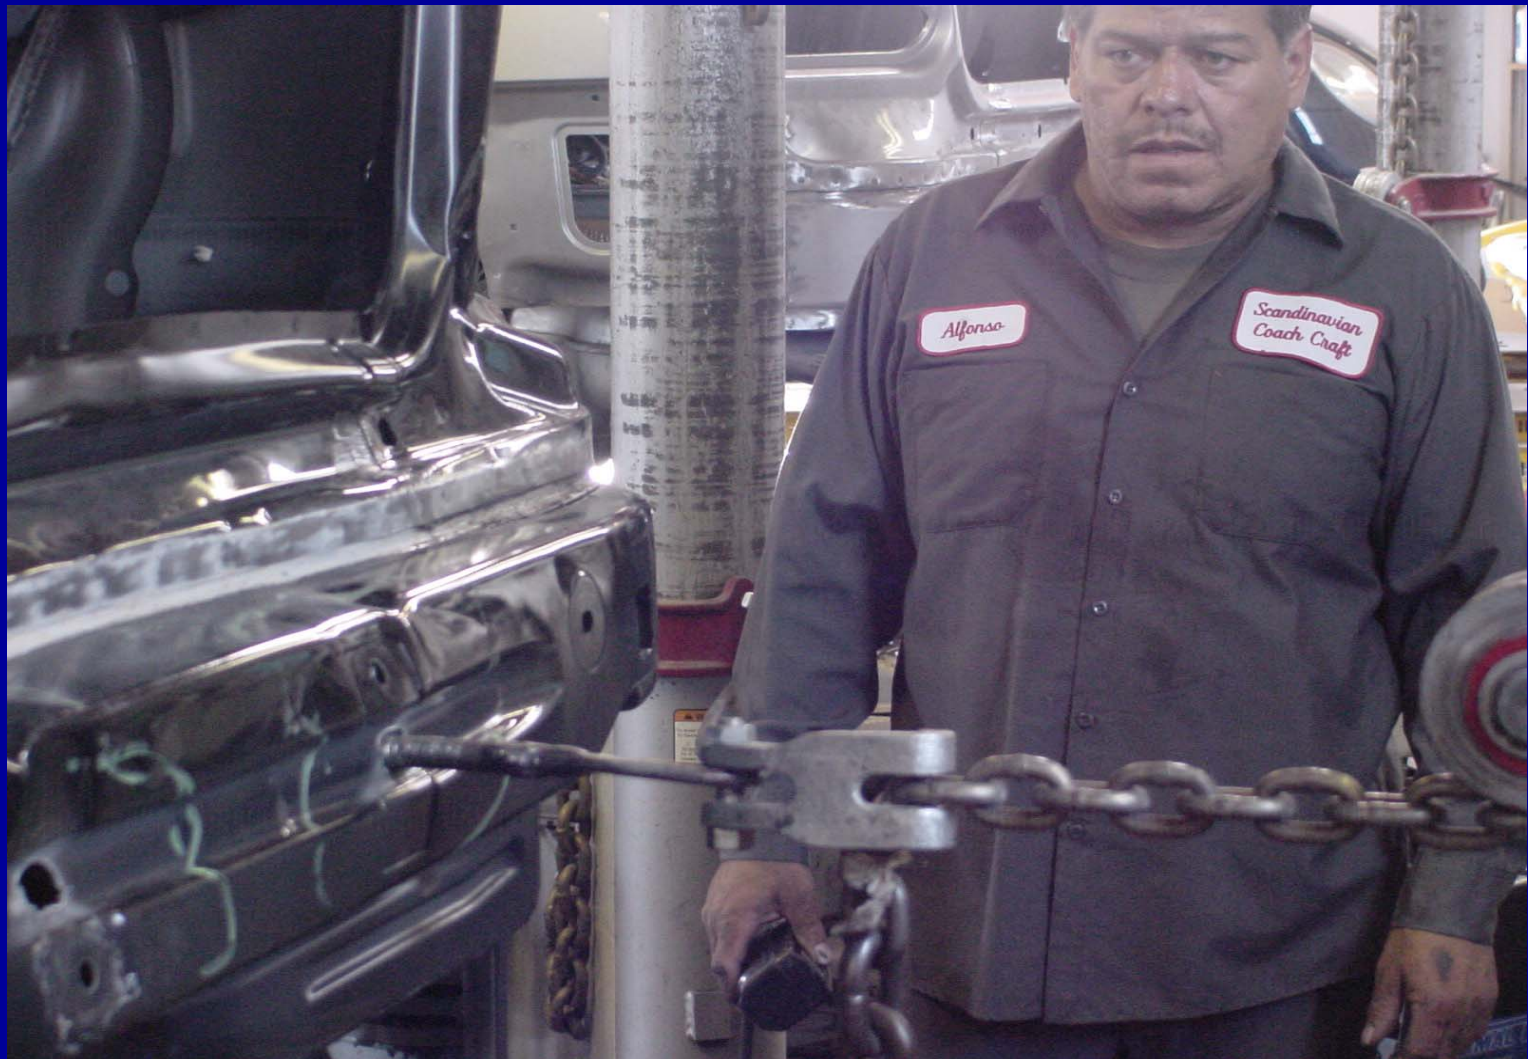
Pull rear bumper reinforcement in order to relieve tension on non-Boron Steel.

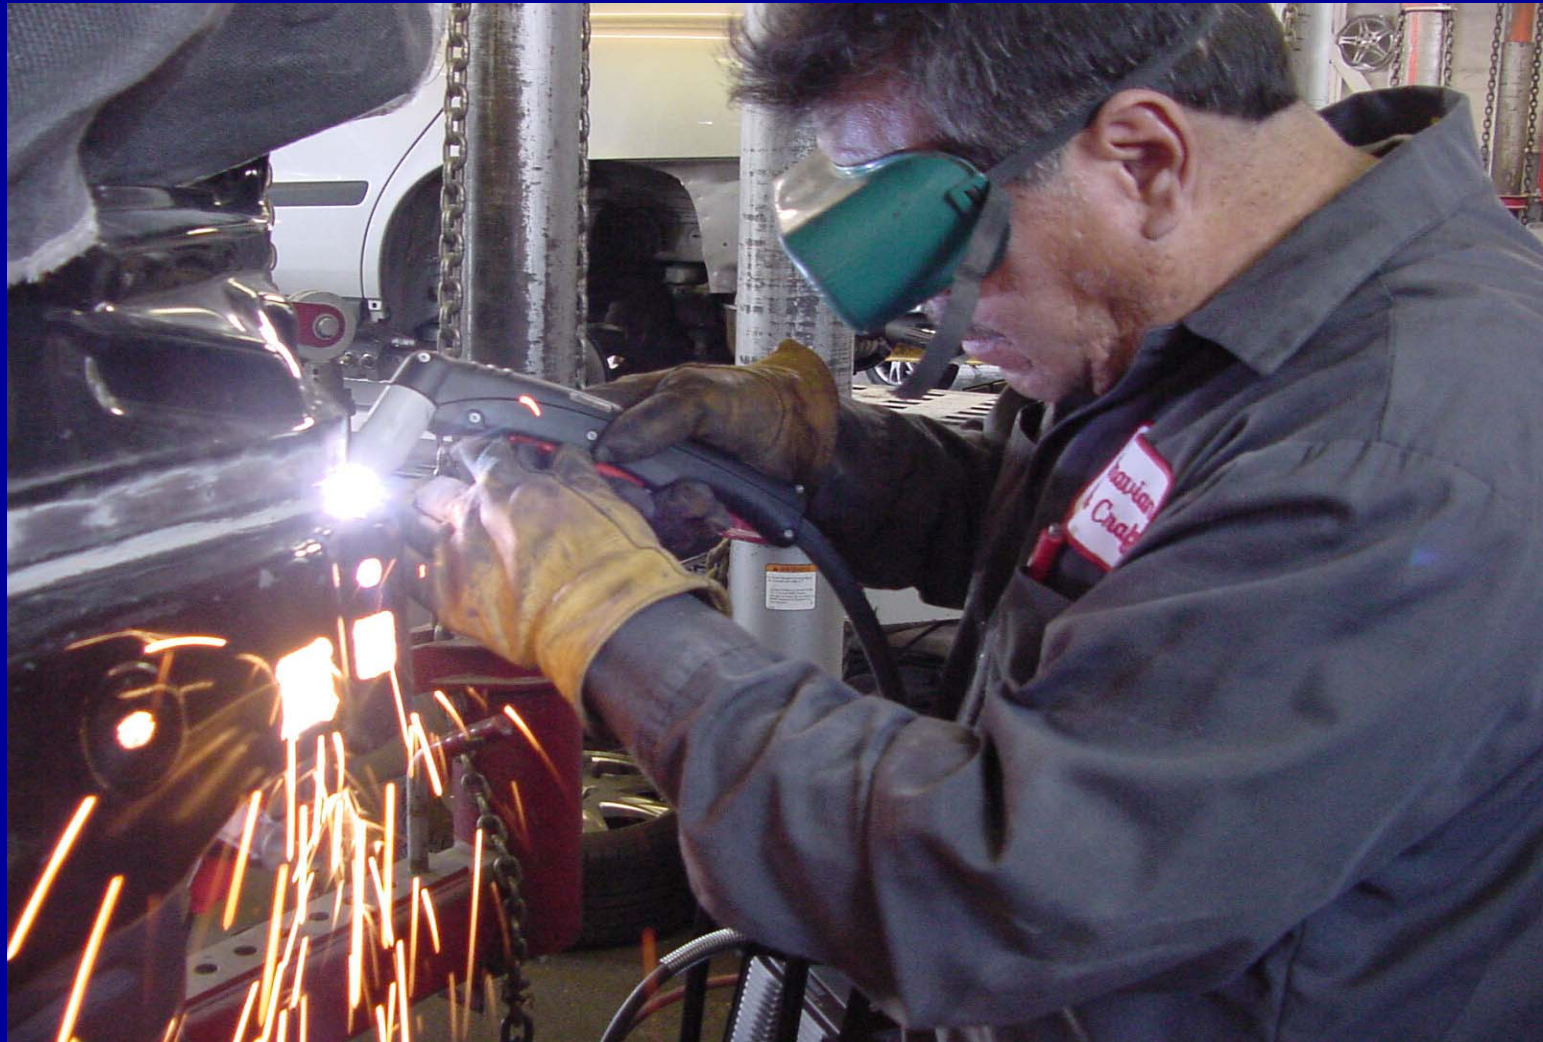
Begin removal of rear bumper reinforcement
with plasma cutter detailed
in the Volvo repair manual.

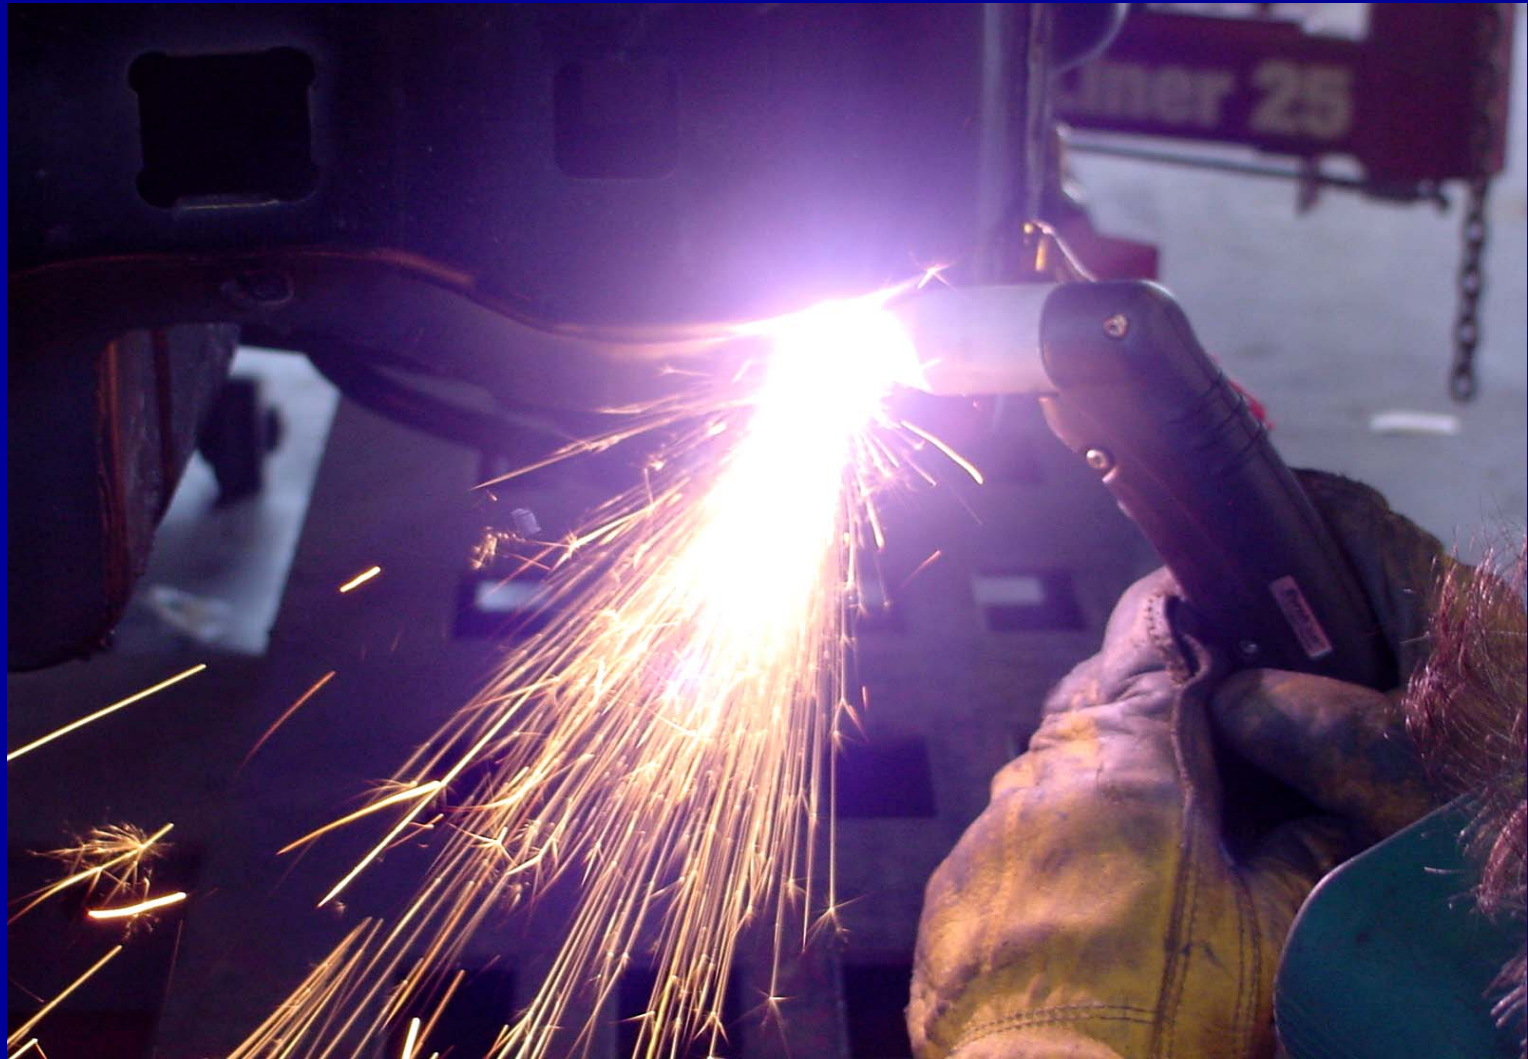
Use plasma cutter to remove factory resistance spot welds.

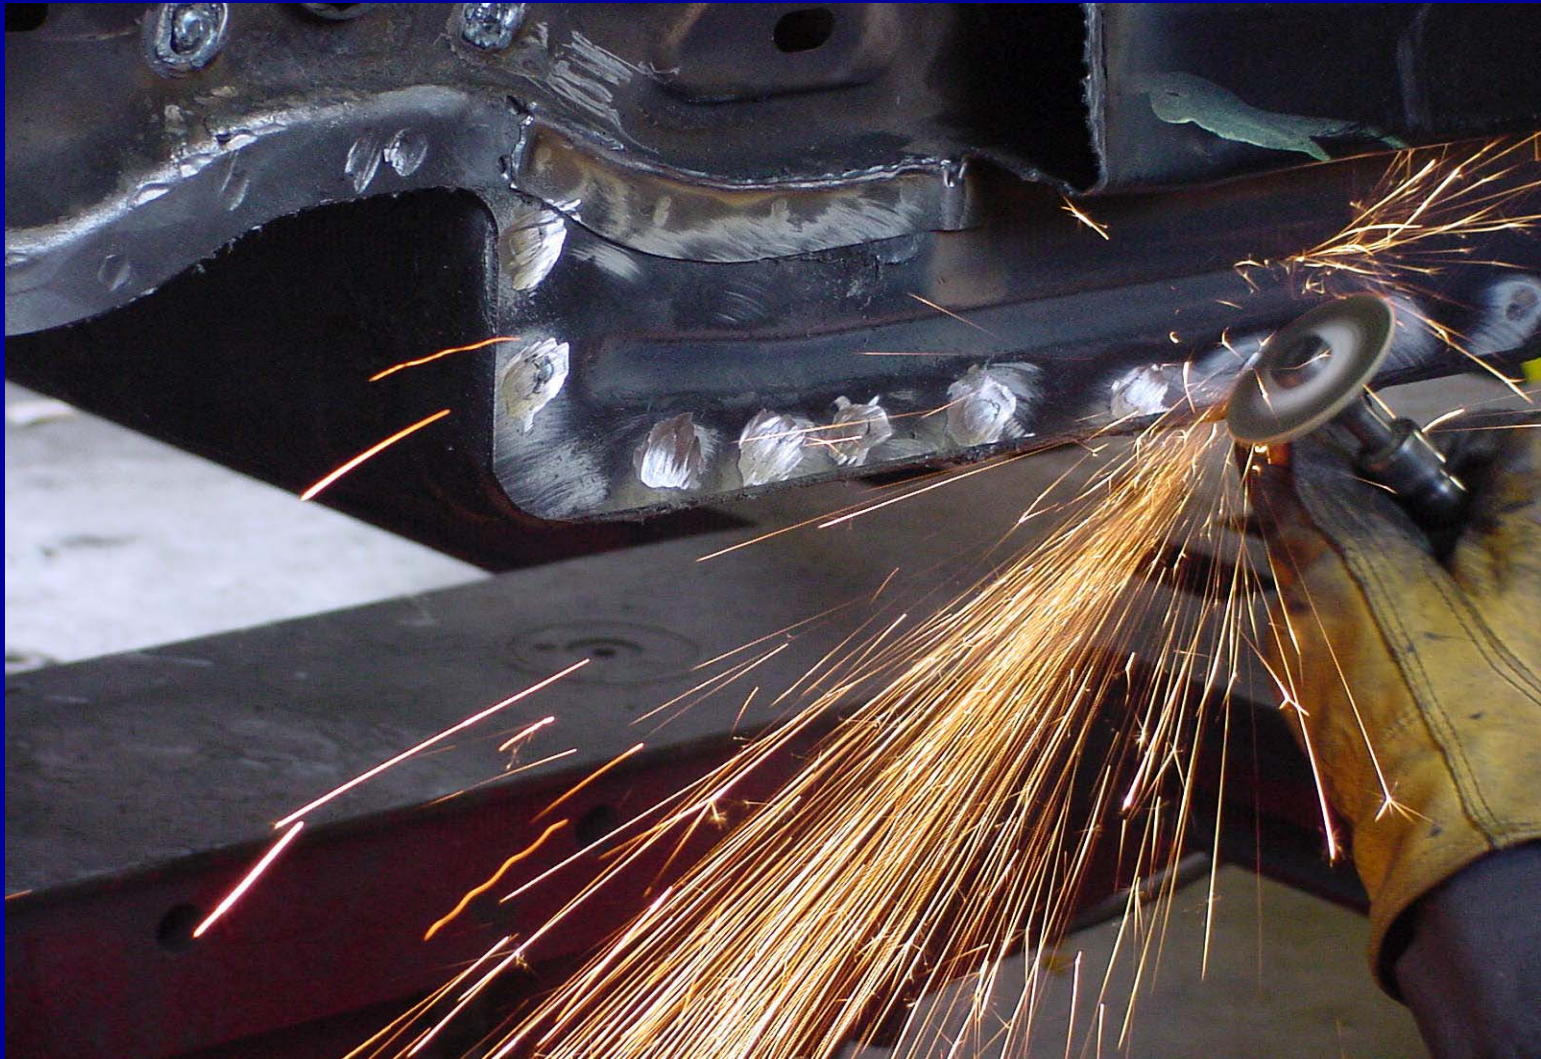
Use a disc grinder to remove spot welds that secures the inner panel to the trunk floor.

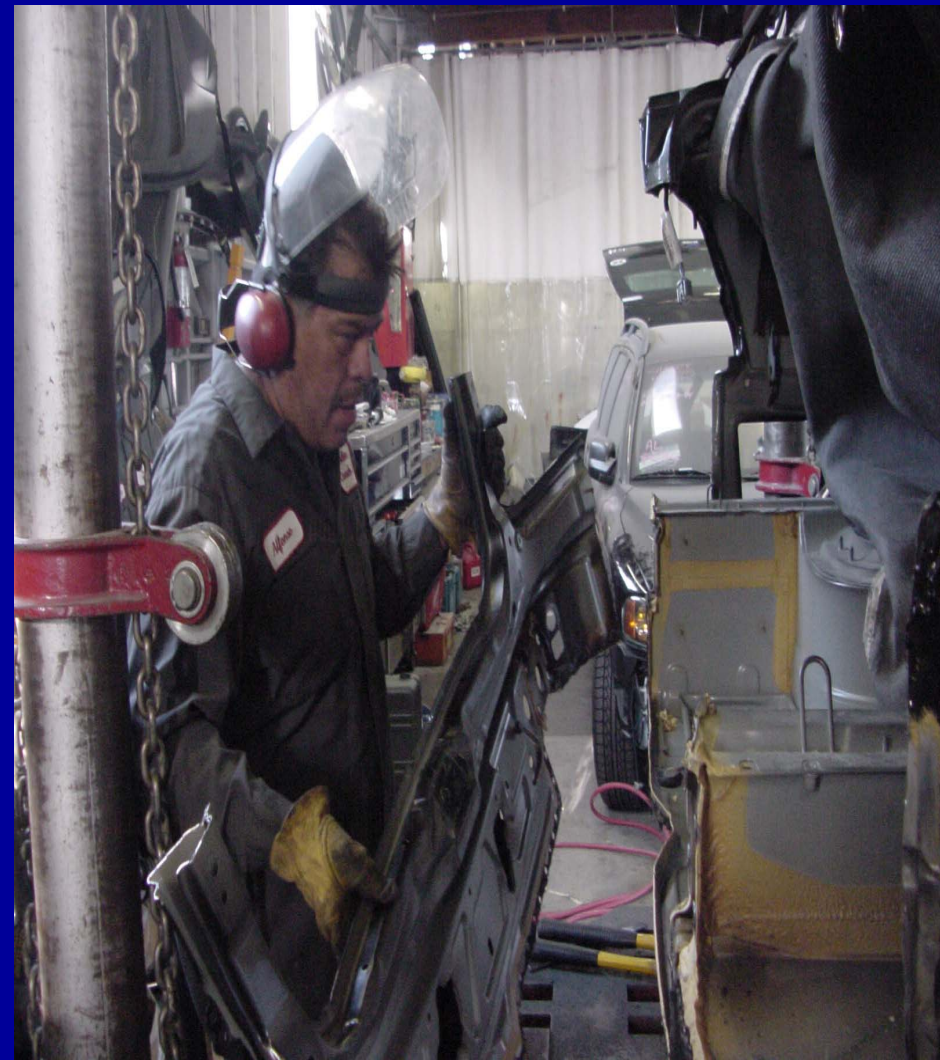
Use the frame machine to remove the rear panel assembly from the vehicle.

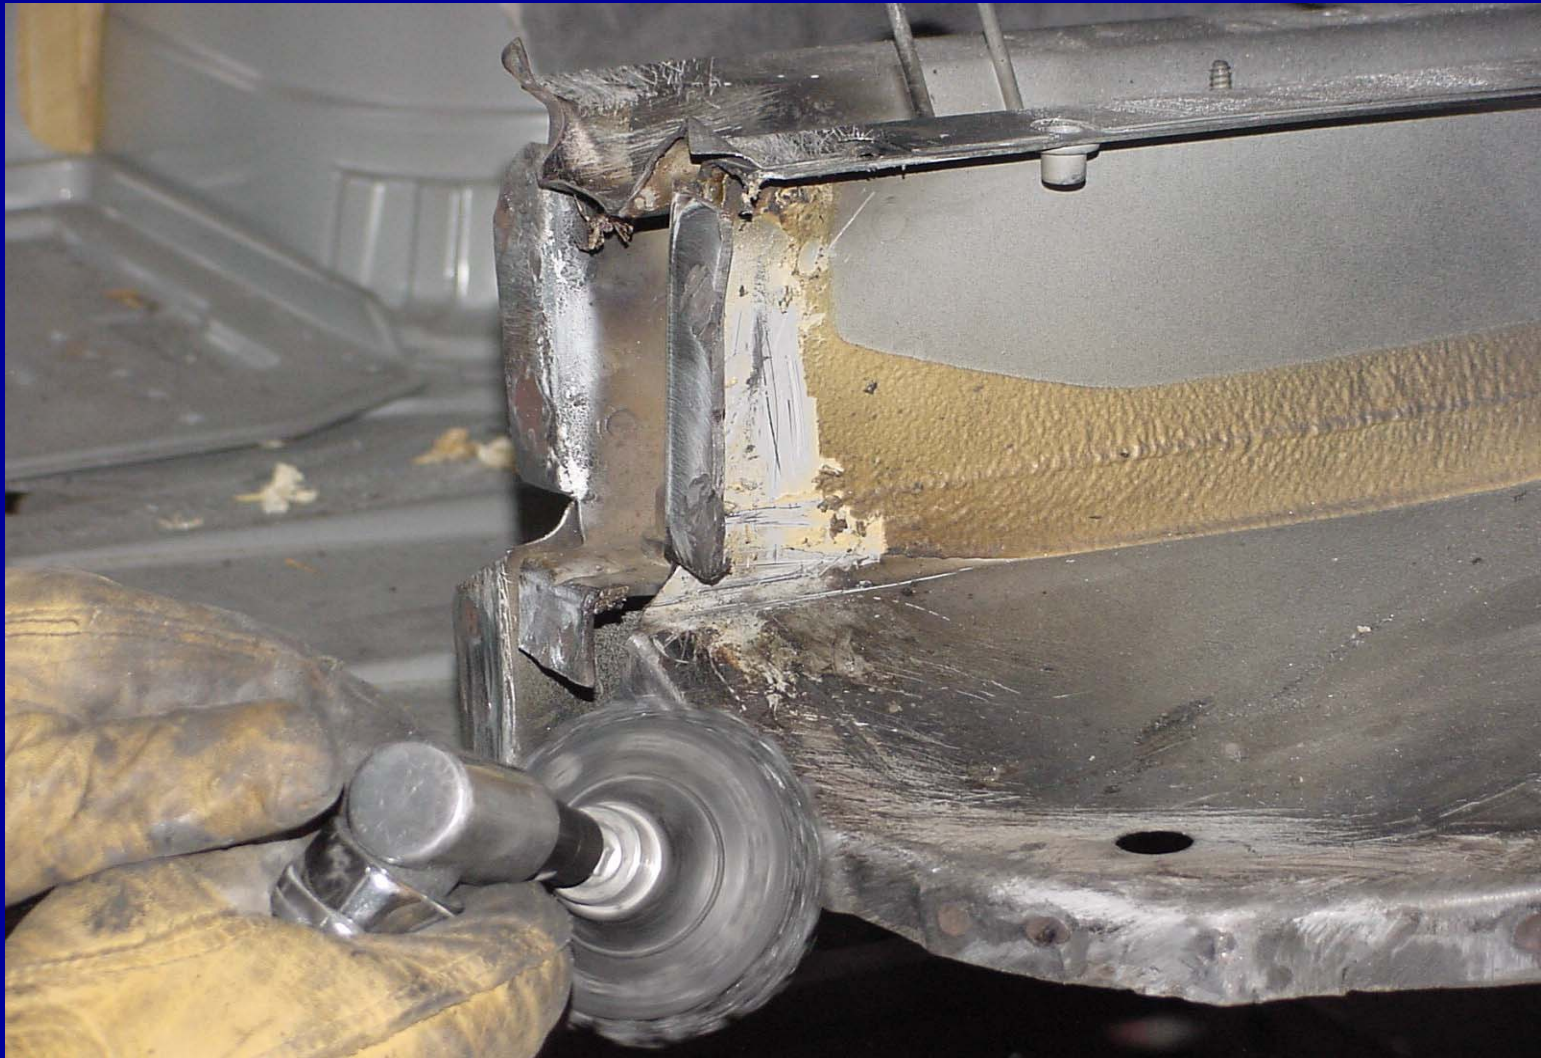
Remove old sealant & caulking from trunk floor.

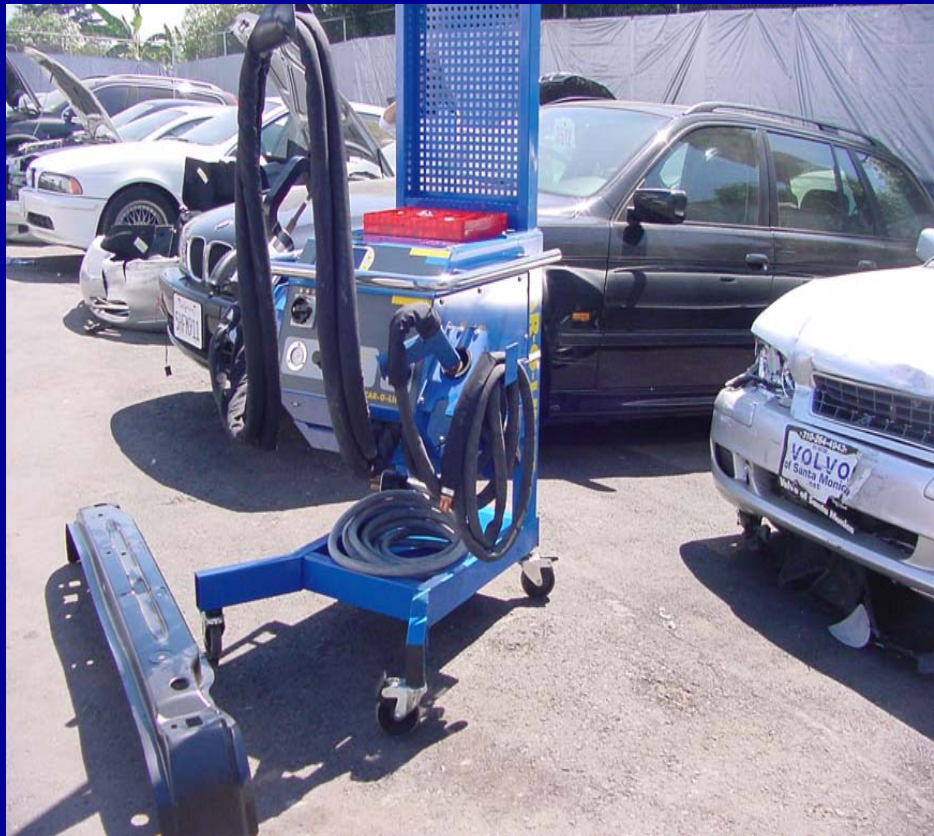
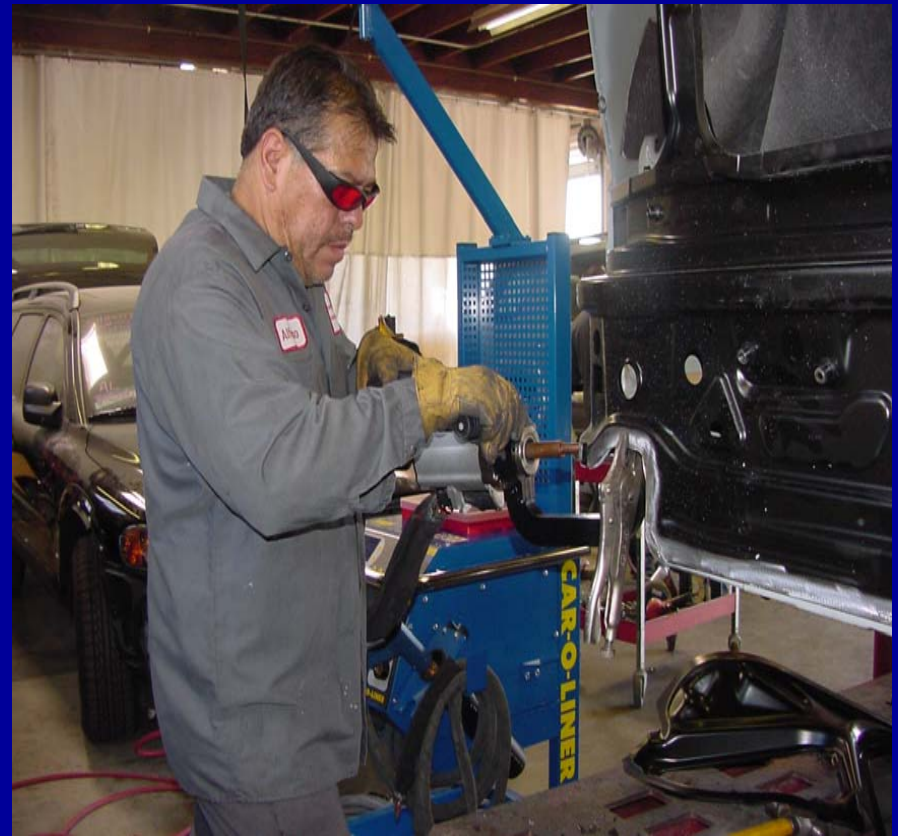
At this point there are 2 options available for the technician to install the inner Boron Steel rear body panel: First he/she can use a resistance spot welded that will work on Born Steel or

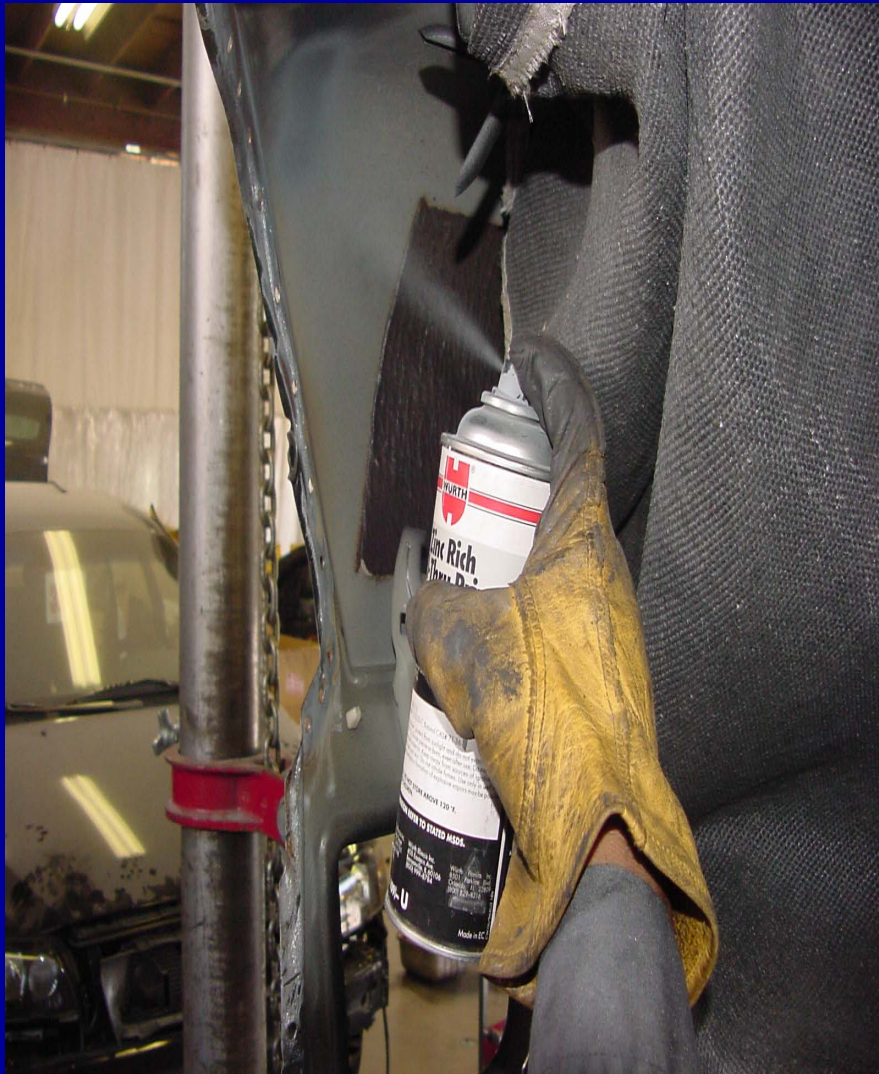
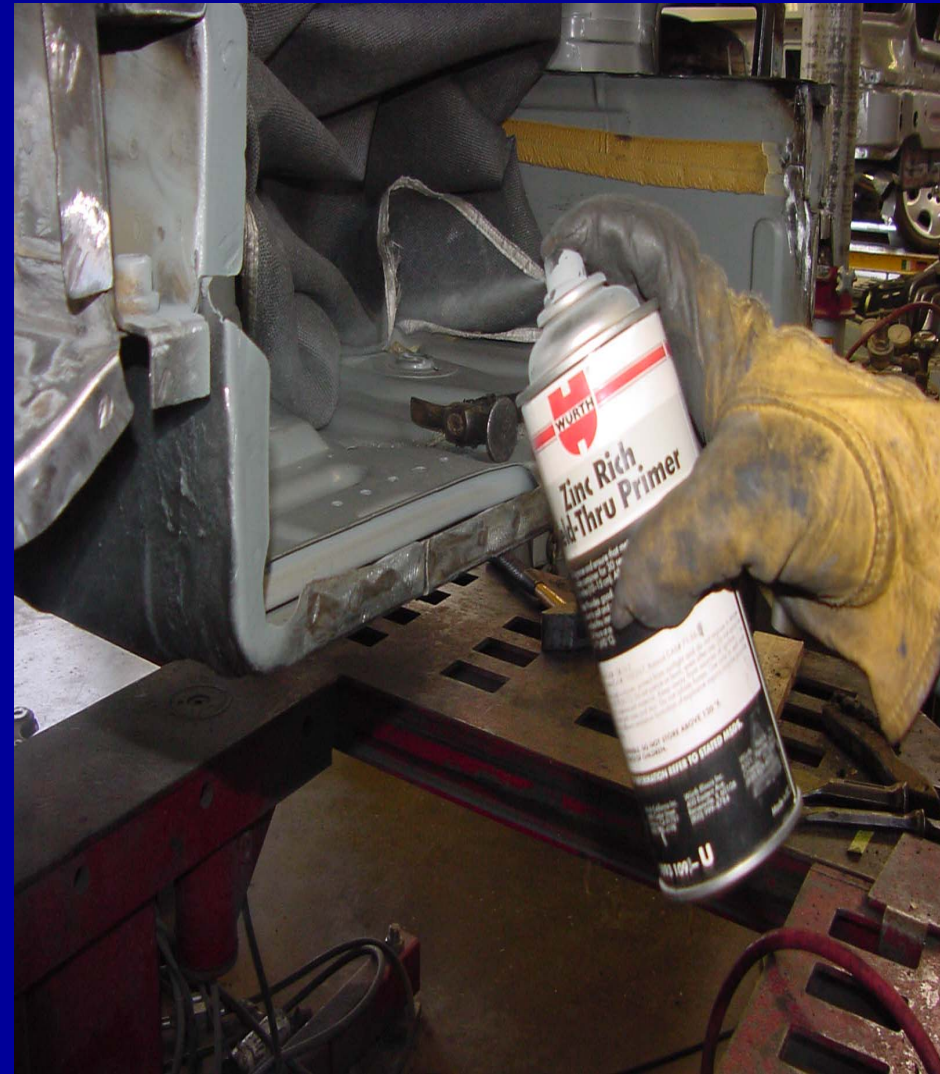
Apply weld thru primer to all mating surfaces that are to be plug welded.

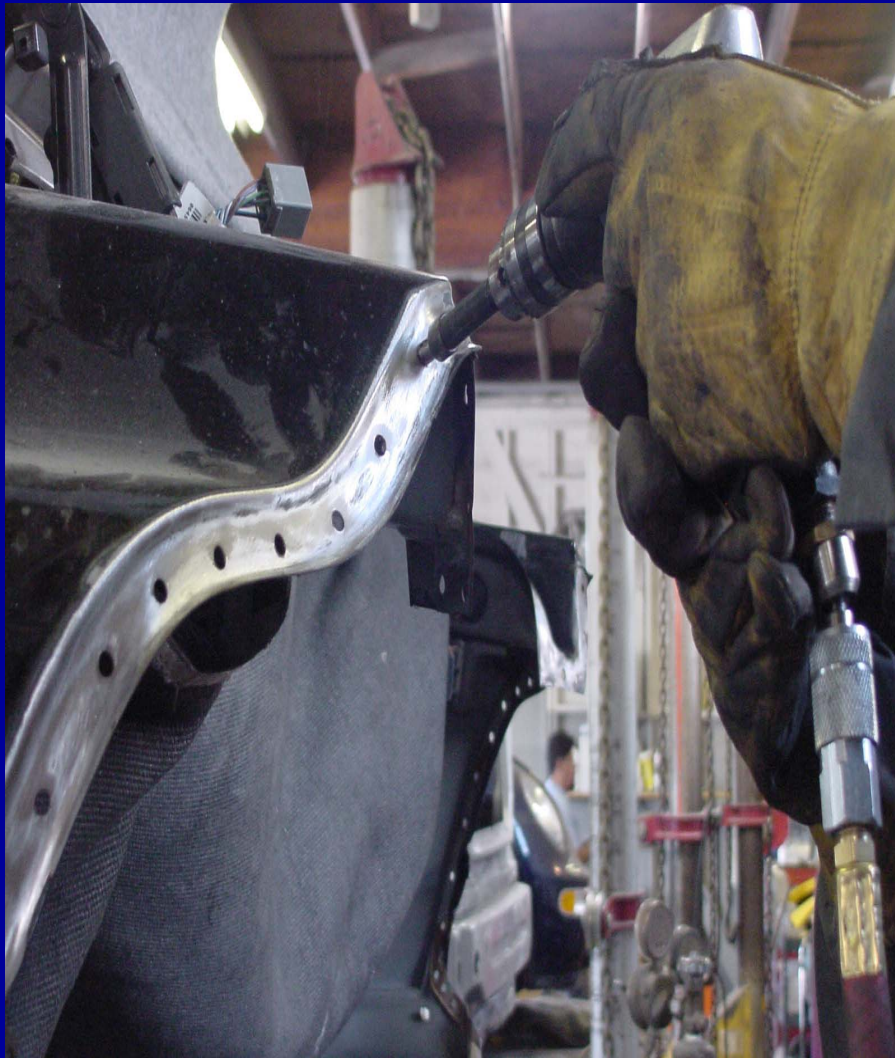
Drill 8 mm holes on quarter panel
& punch trunk floor.

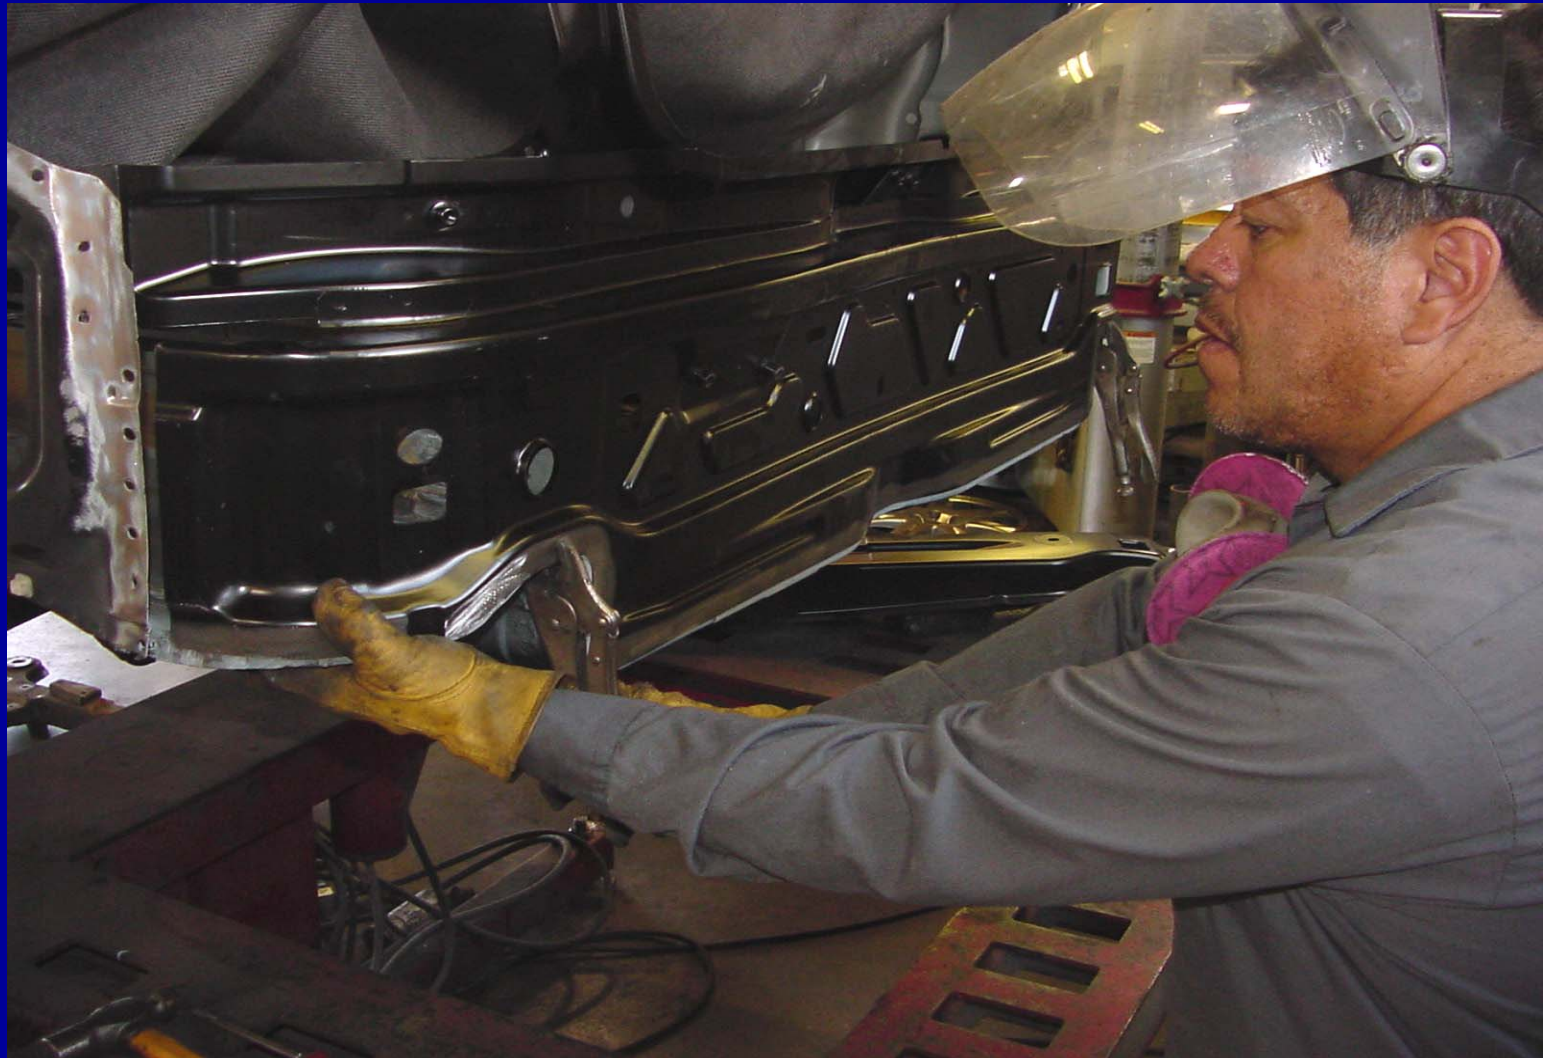
Clamp rear body panel to vehicle to trial fit & mark plug hole locations.

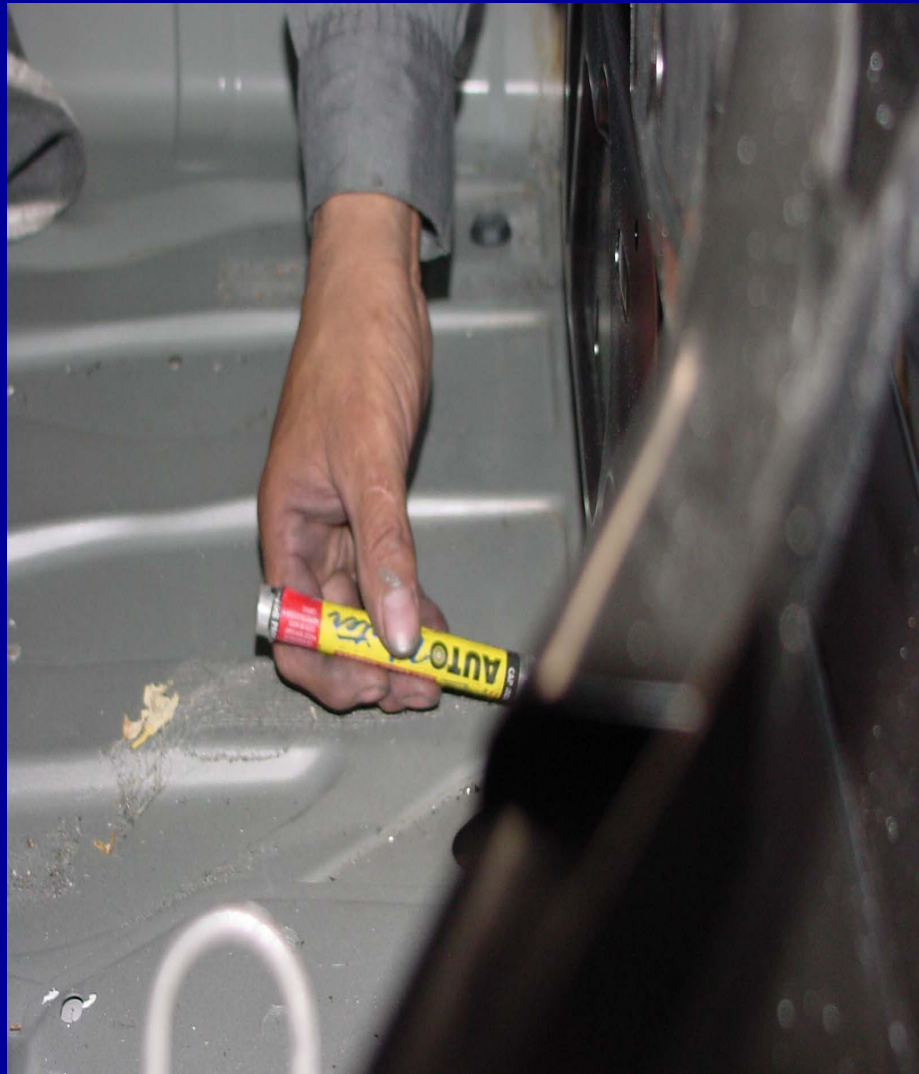
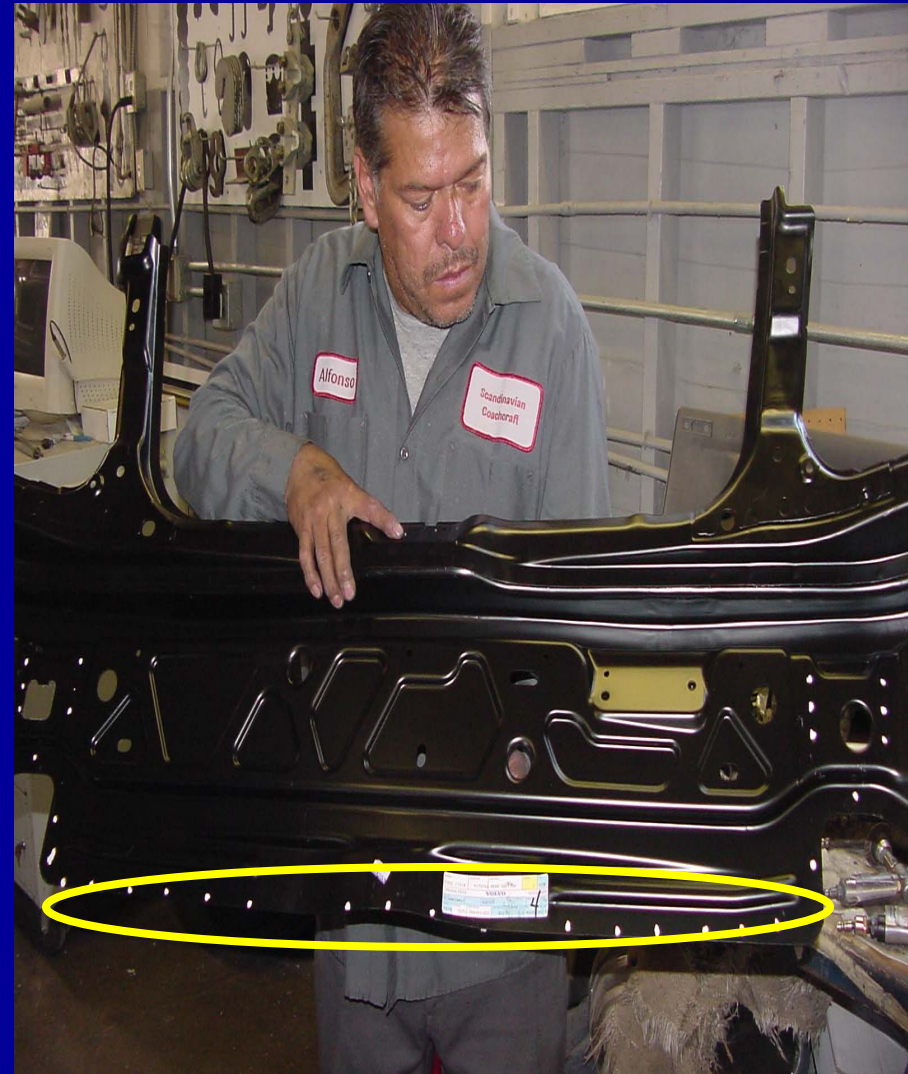
Mark the location of the plug weld holes on the backside of the rear body panel.
