Collision Industry Conference

Write-It-Right Committee

Aluminum Rail Replacement on a 2004 and Newer 5 Series BMW

Replacing a Boron Steel Panel

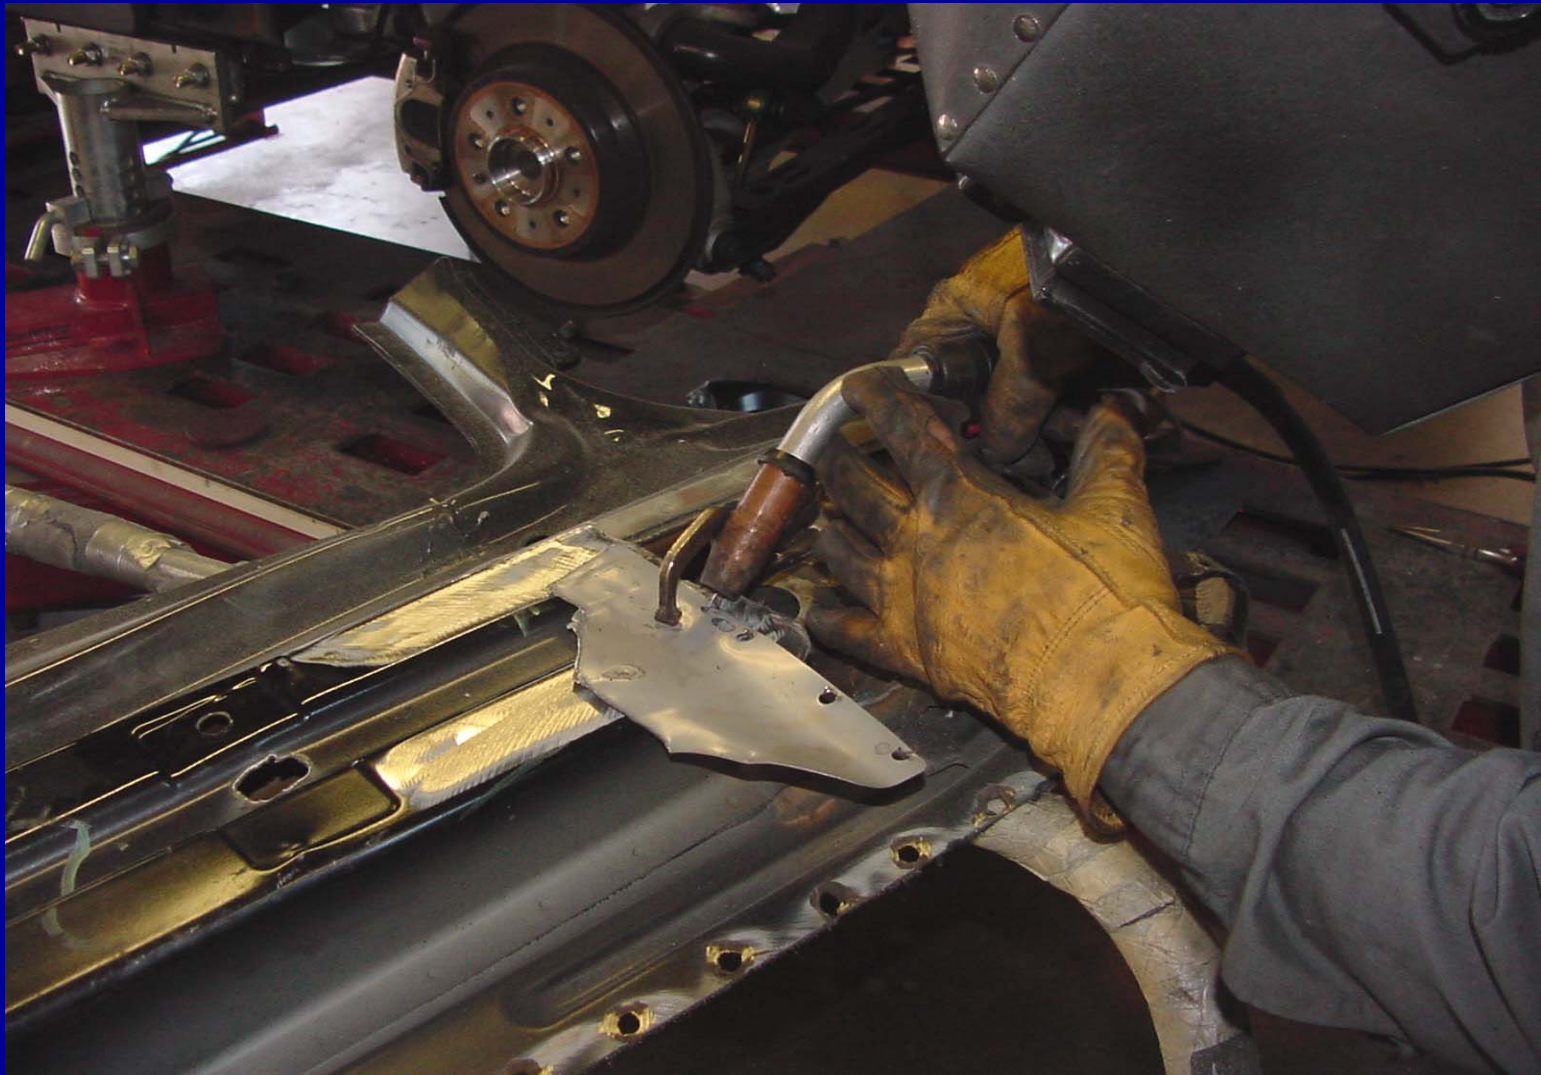
Perform test welds using the old Boron Steel rear body panel as recommended by I-CAR.

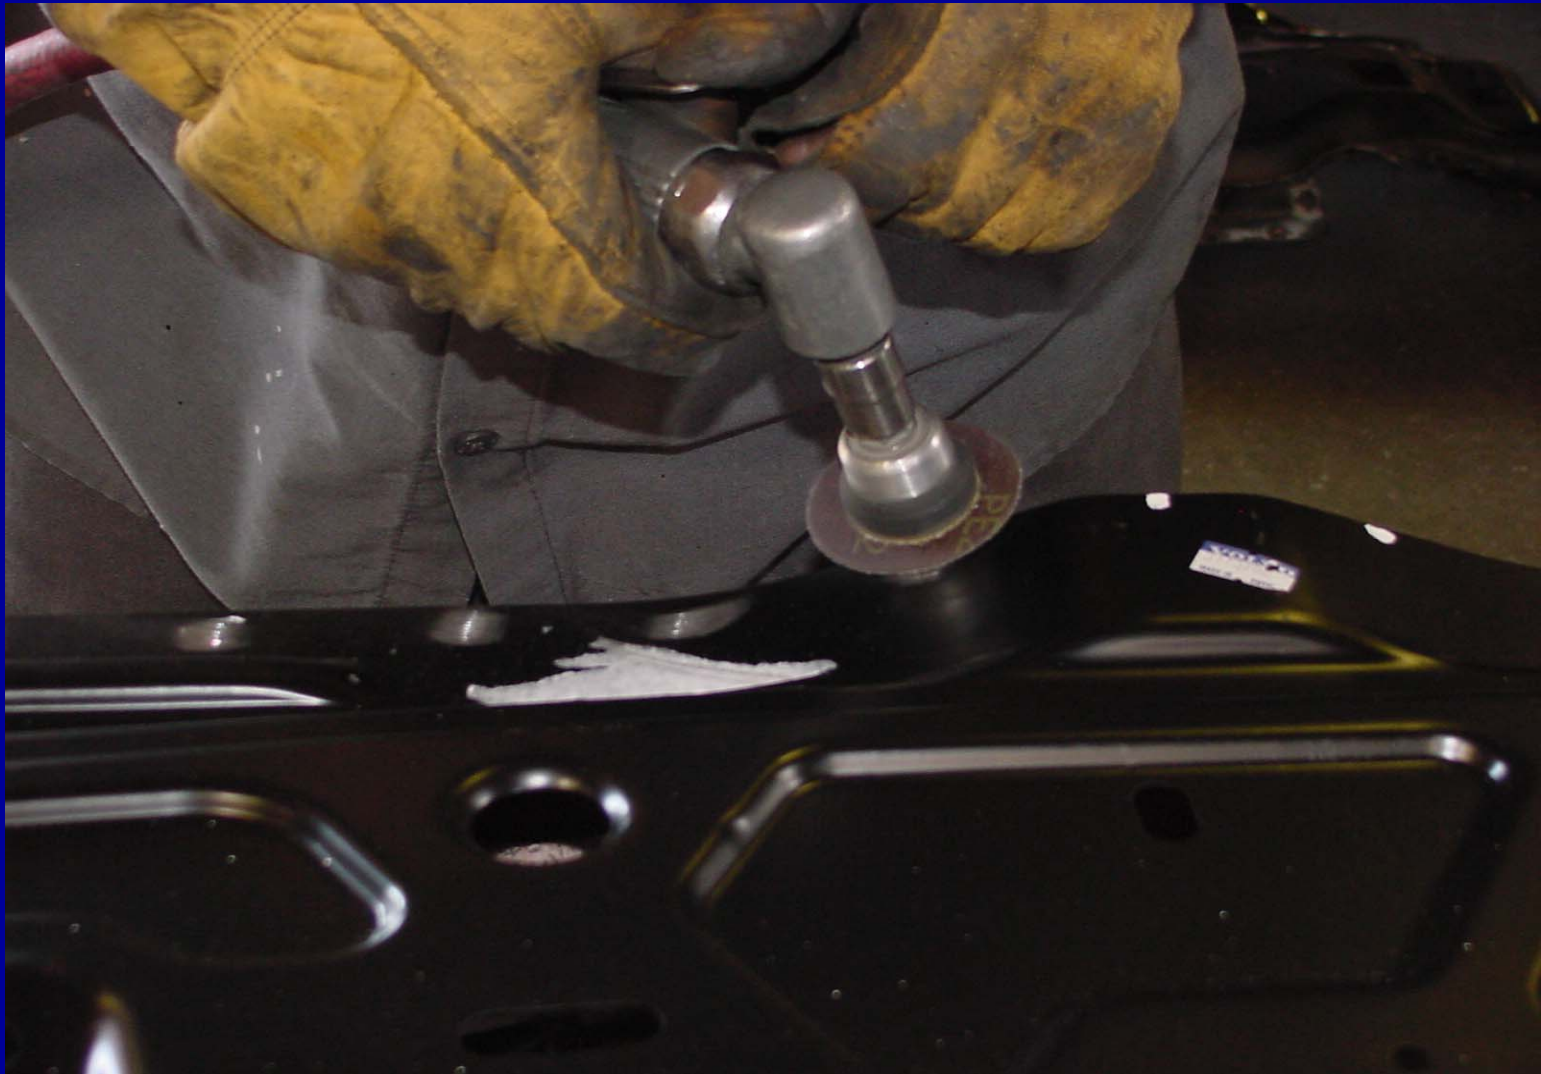
Remove small amount of the factory E-coat at marked locations

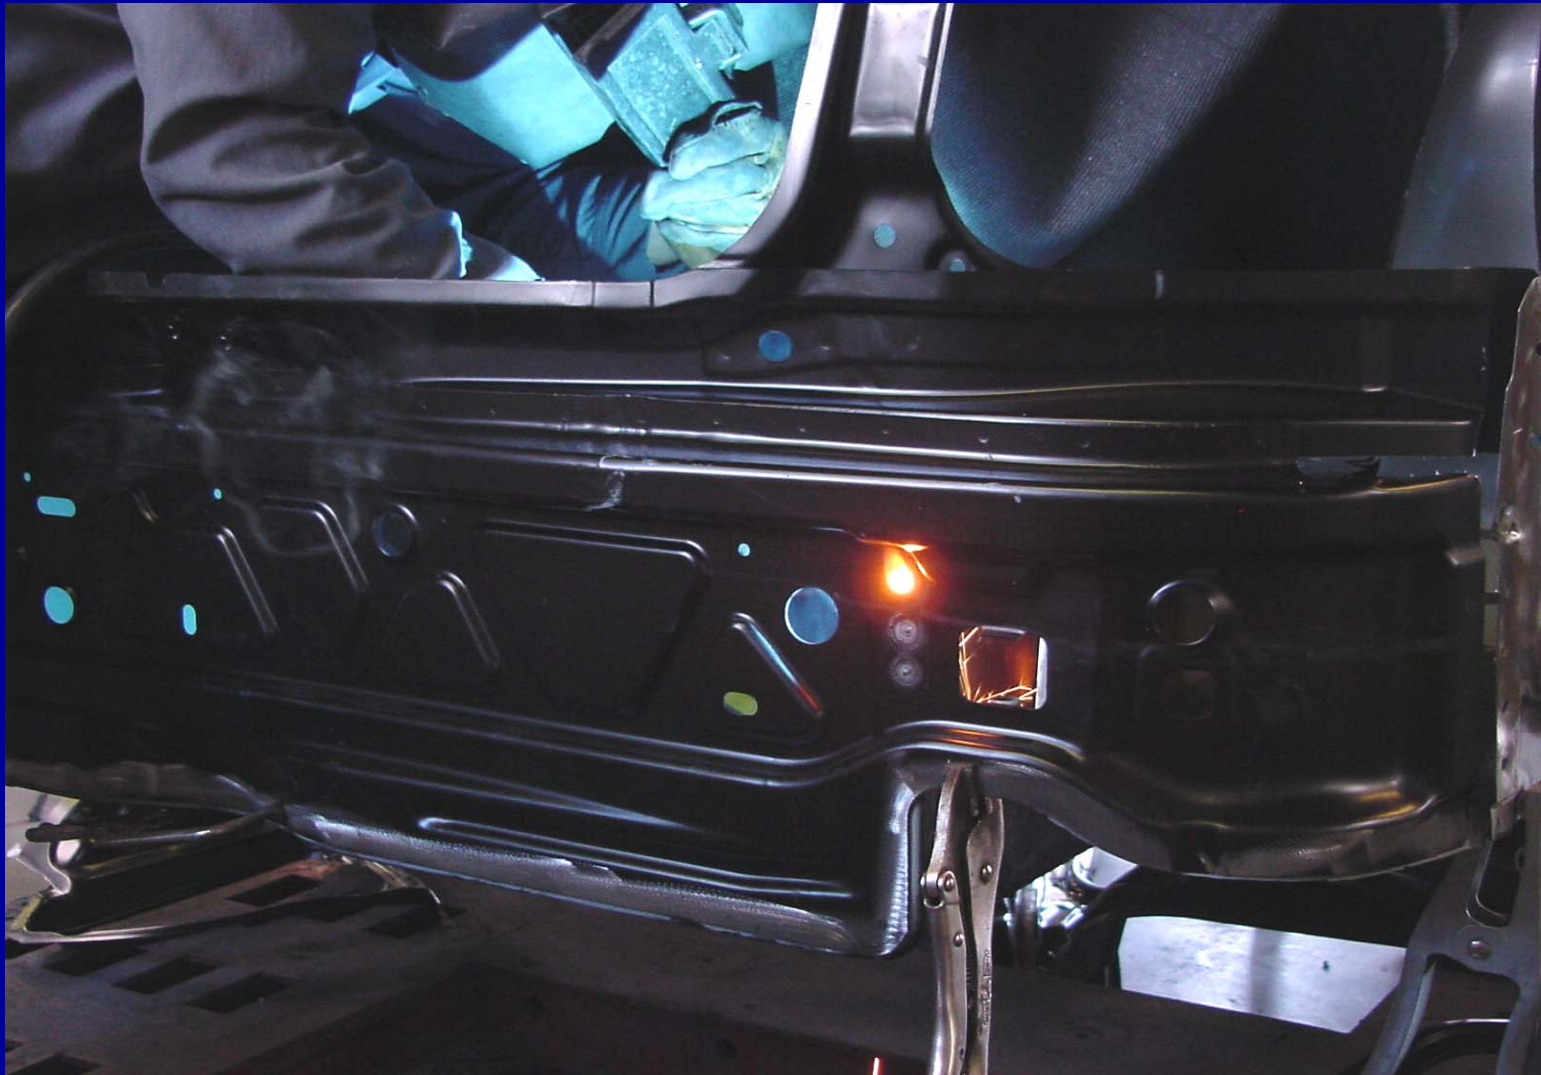
Plug weld the frame rail to the rear body panel (it was easier for the tech to drill holes in the frame rail ends instead of rear body panel).

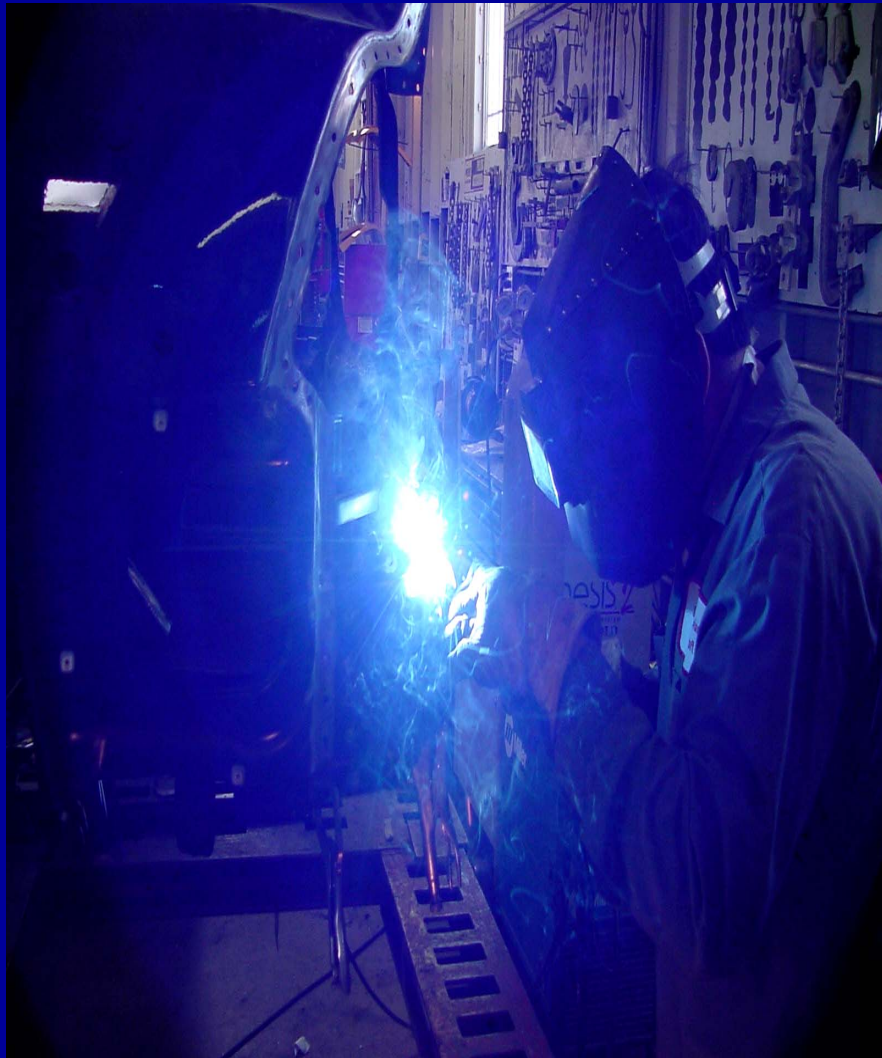
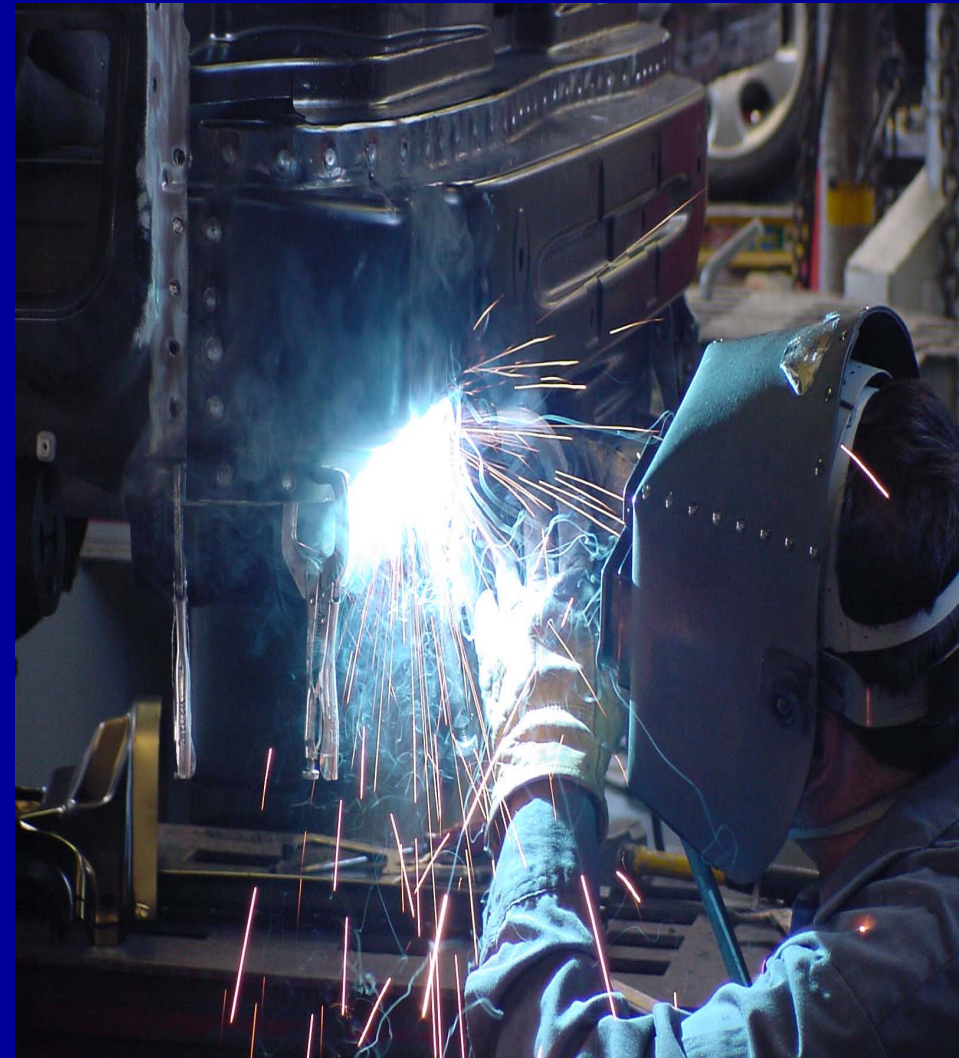
Plug weld the outer Boron Steel rear bumper reinforcement to the vehicle using a MIG welder.

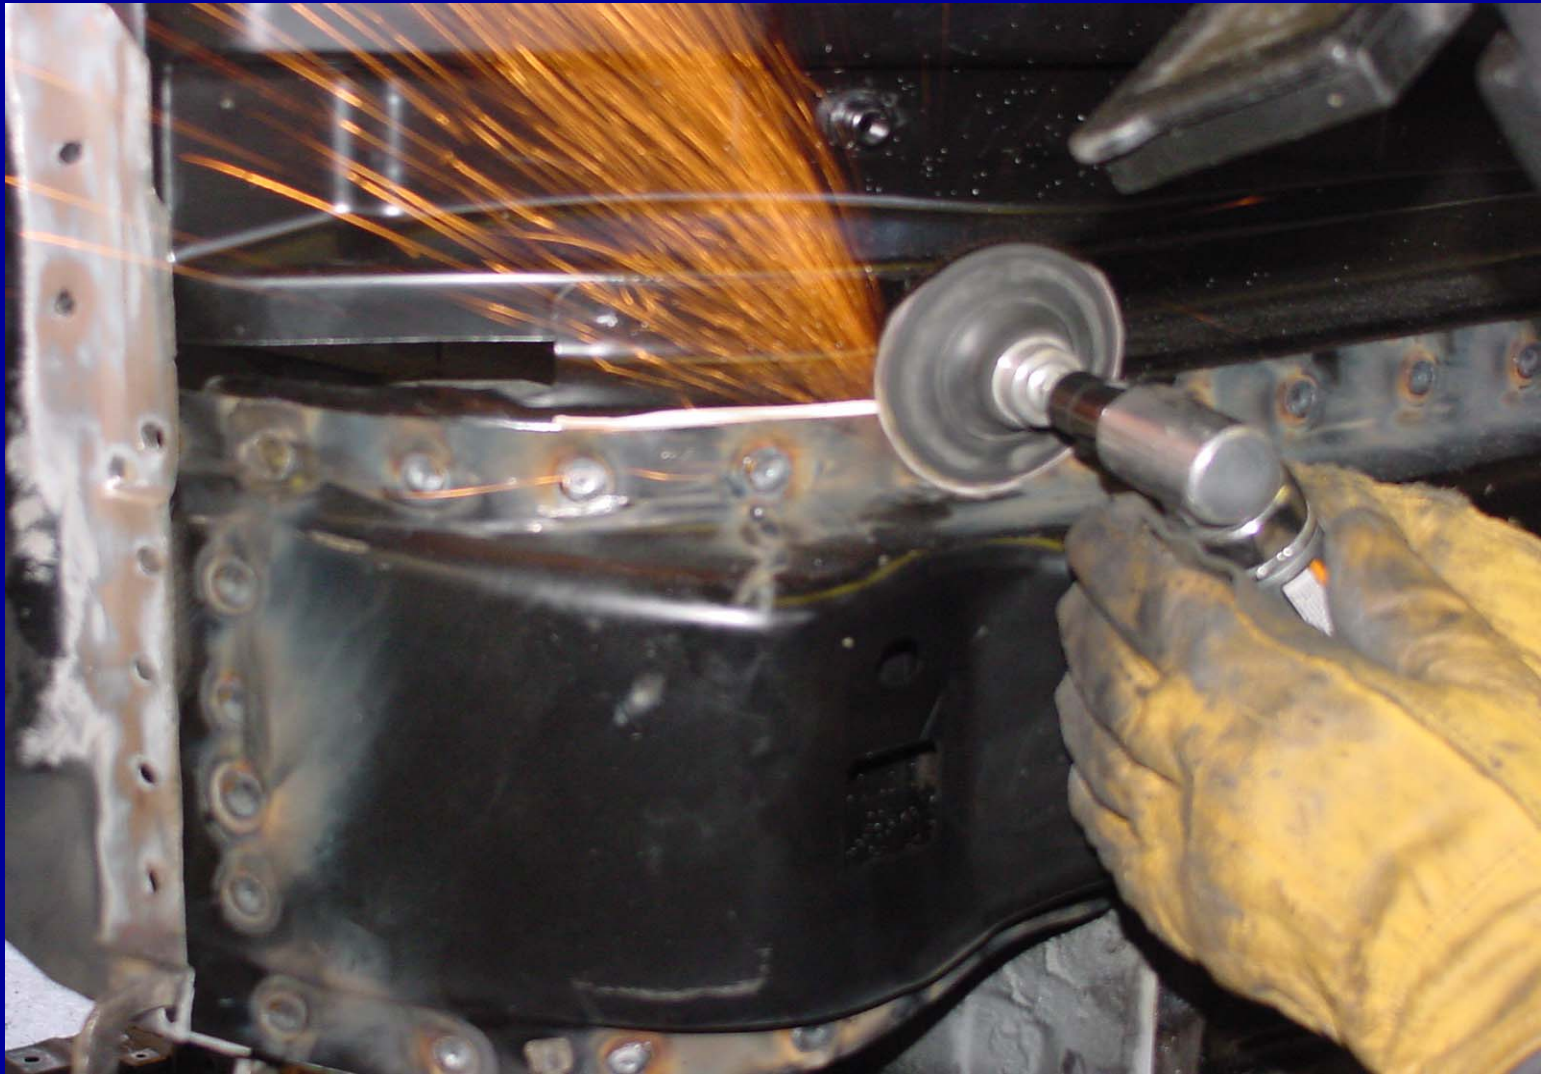
Dress the plug welds on the outer Boron Steel bumper reinforcement.

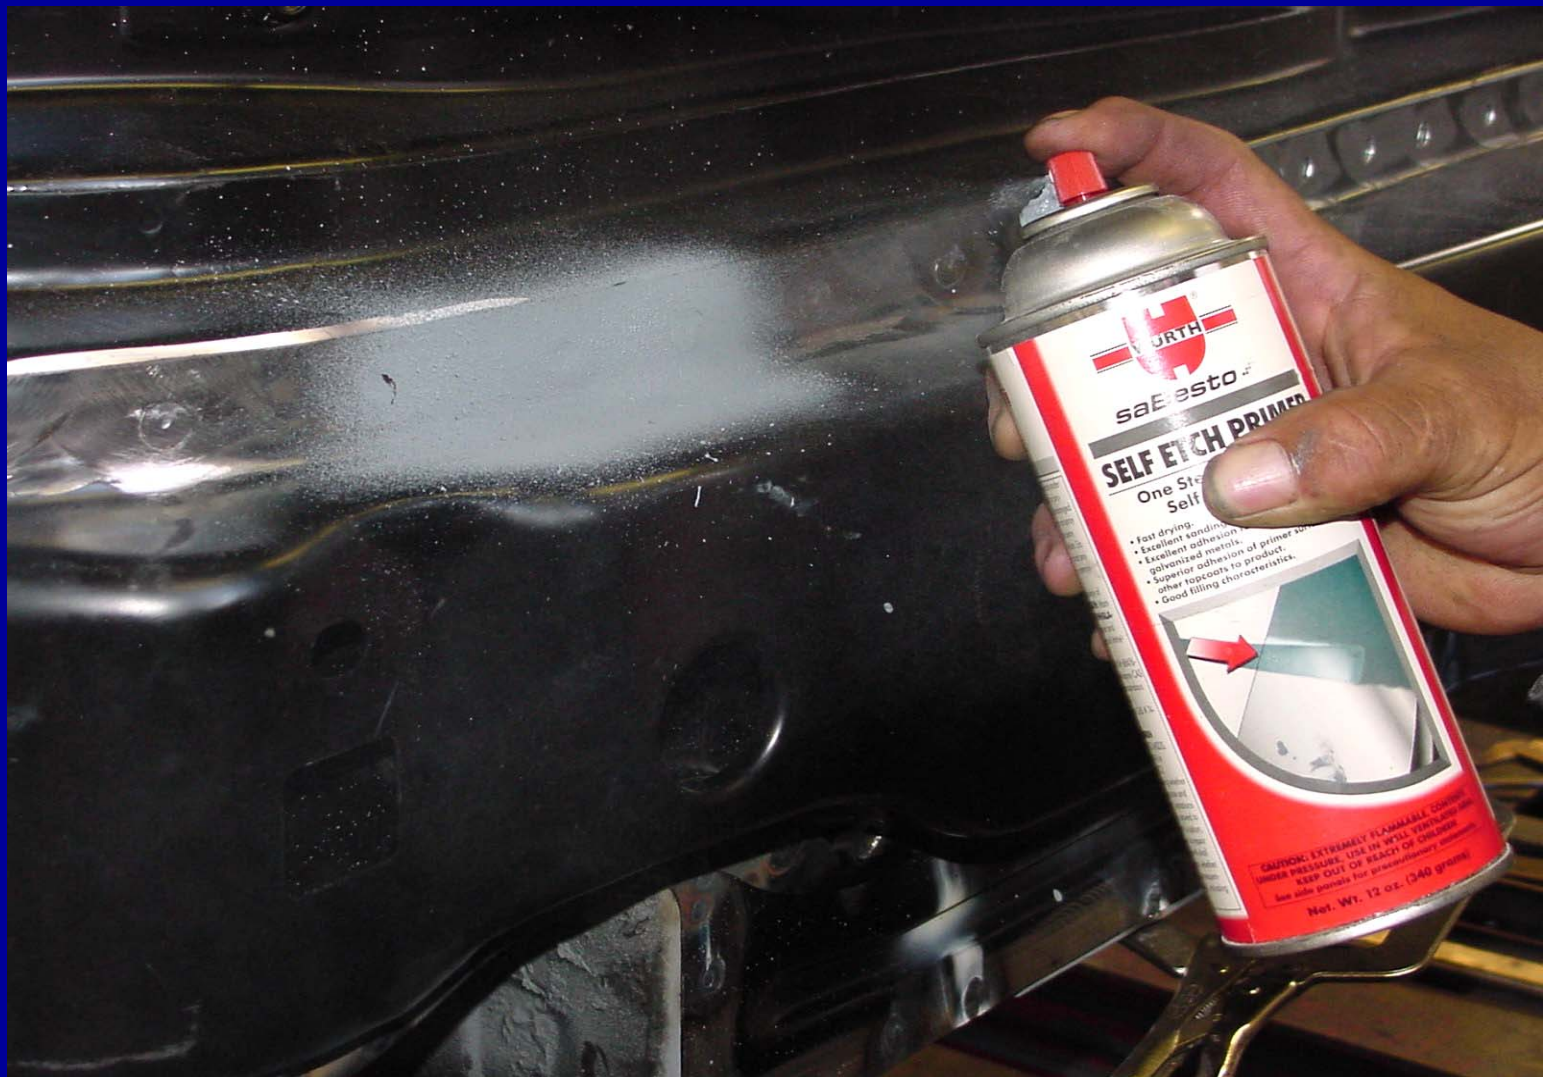
Apply a self etch primer to the bare metal on the outer Boron Steel rear bumper reinforcement.

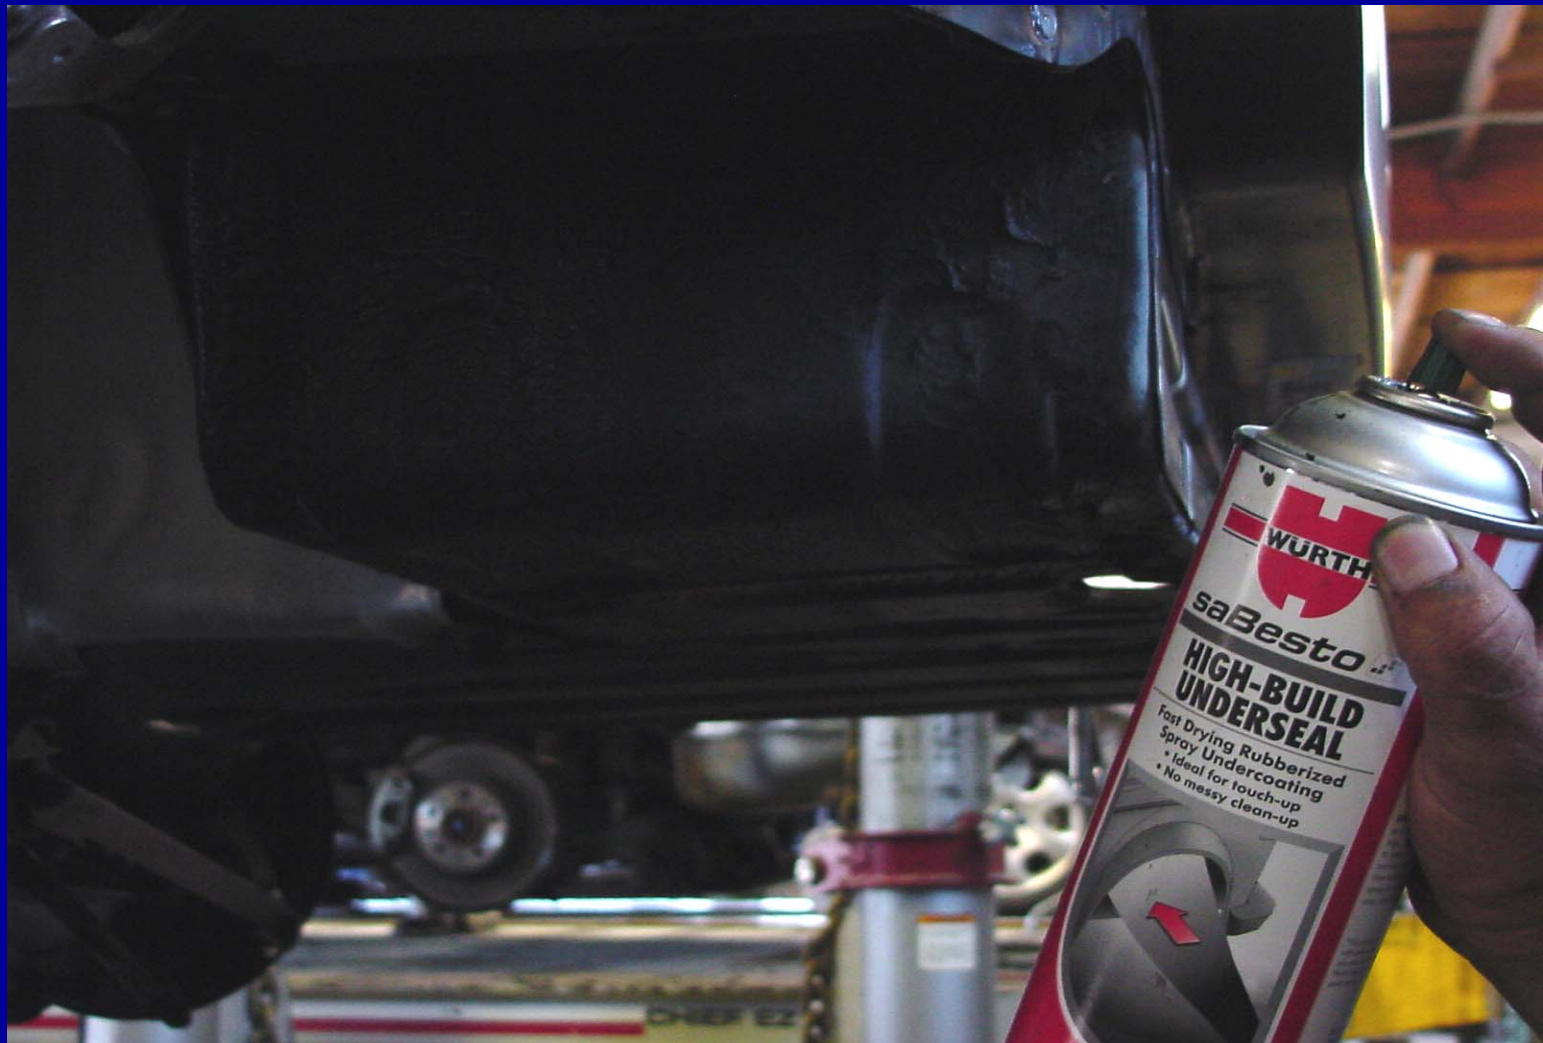
Apply undercoating to the rear
frame rails.

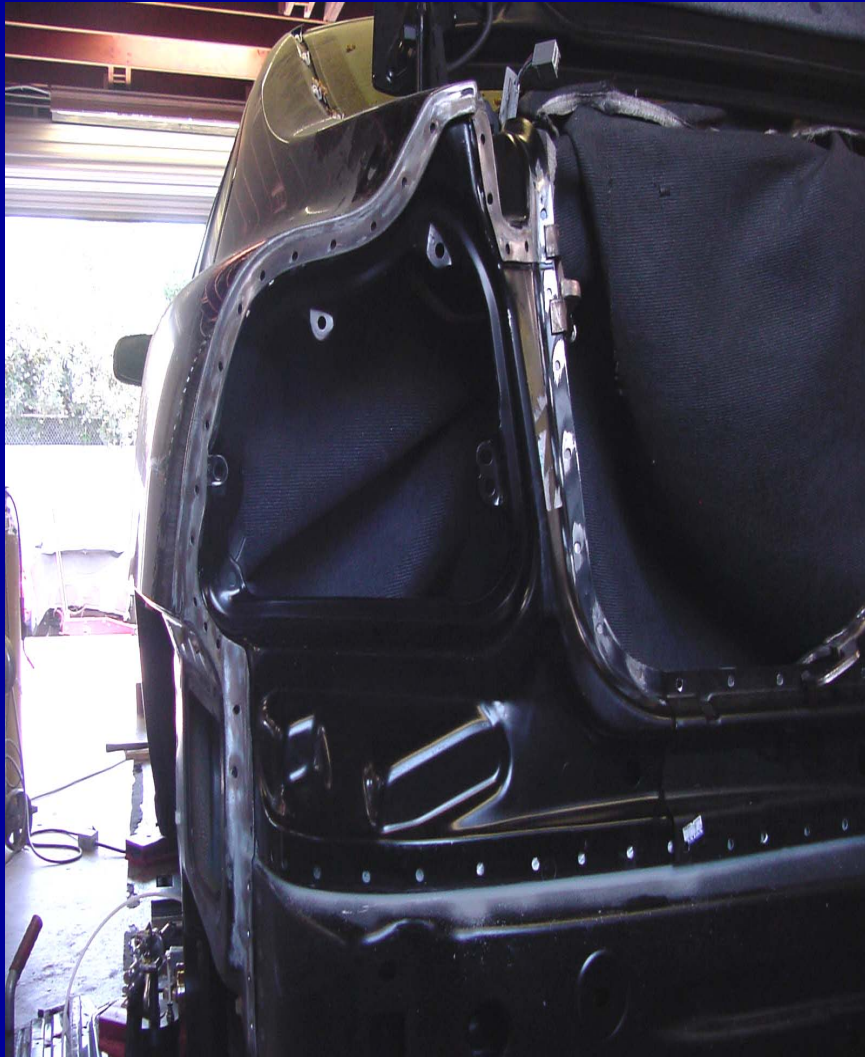
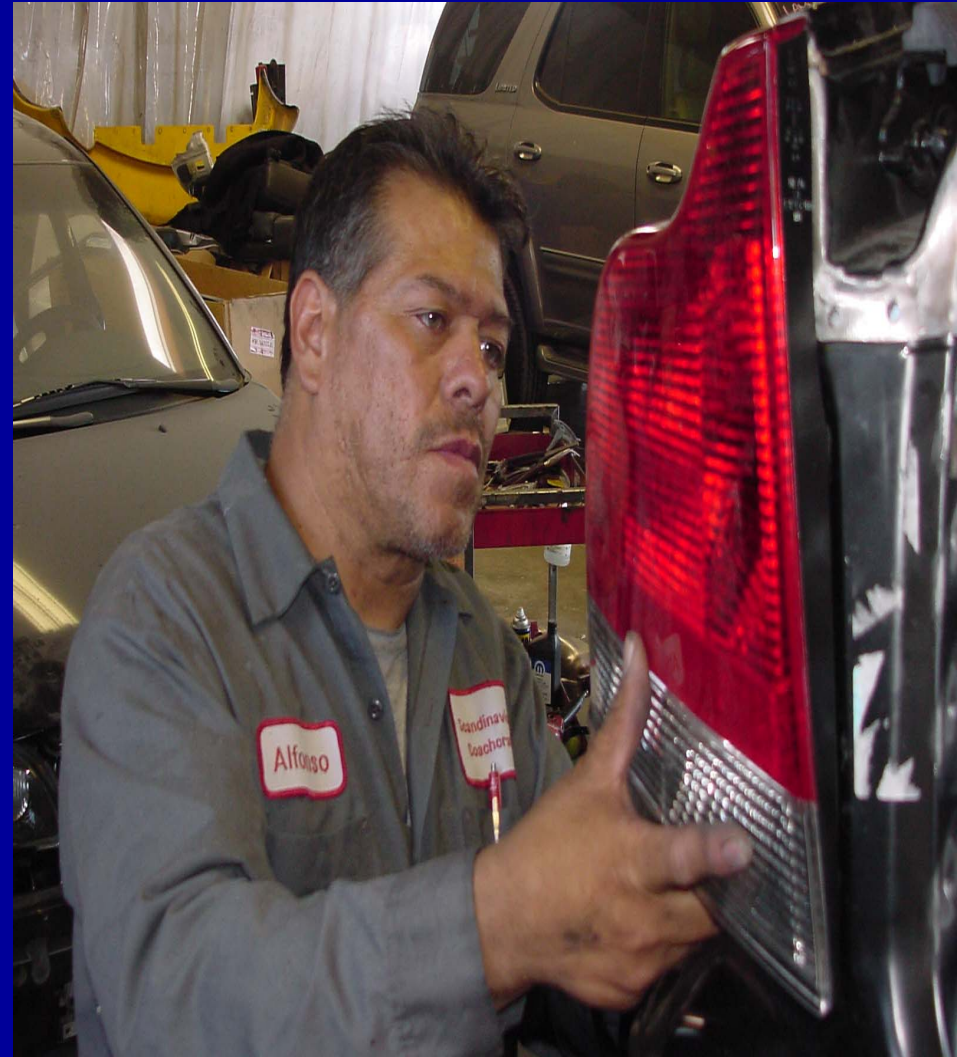
Install the tail lamp pocket & trial fit the tail lamp assembly

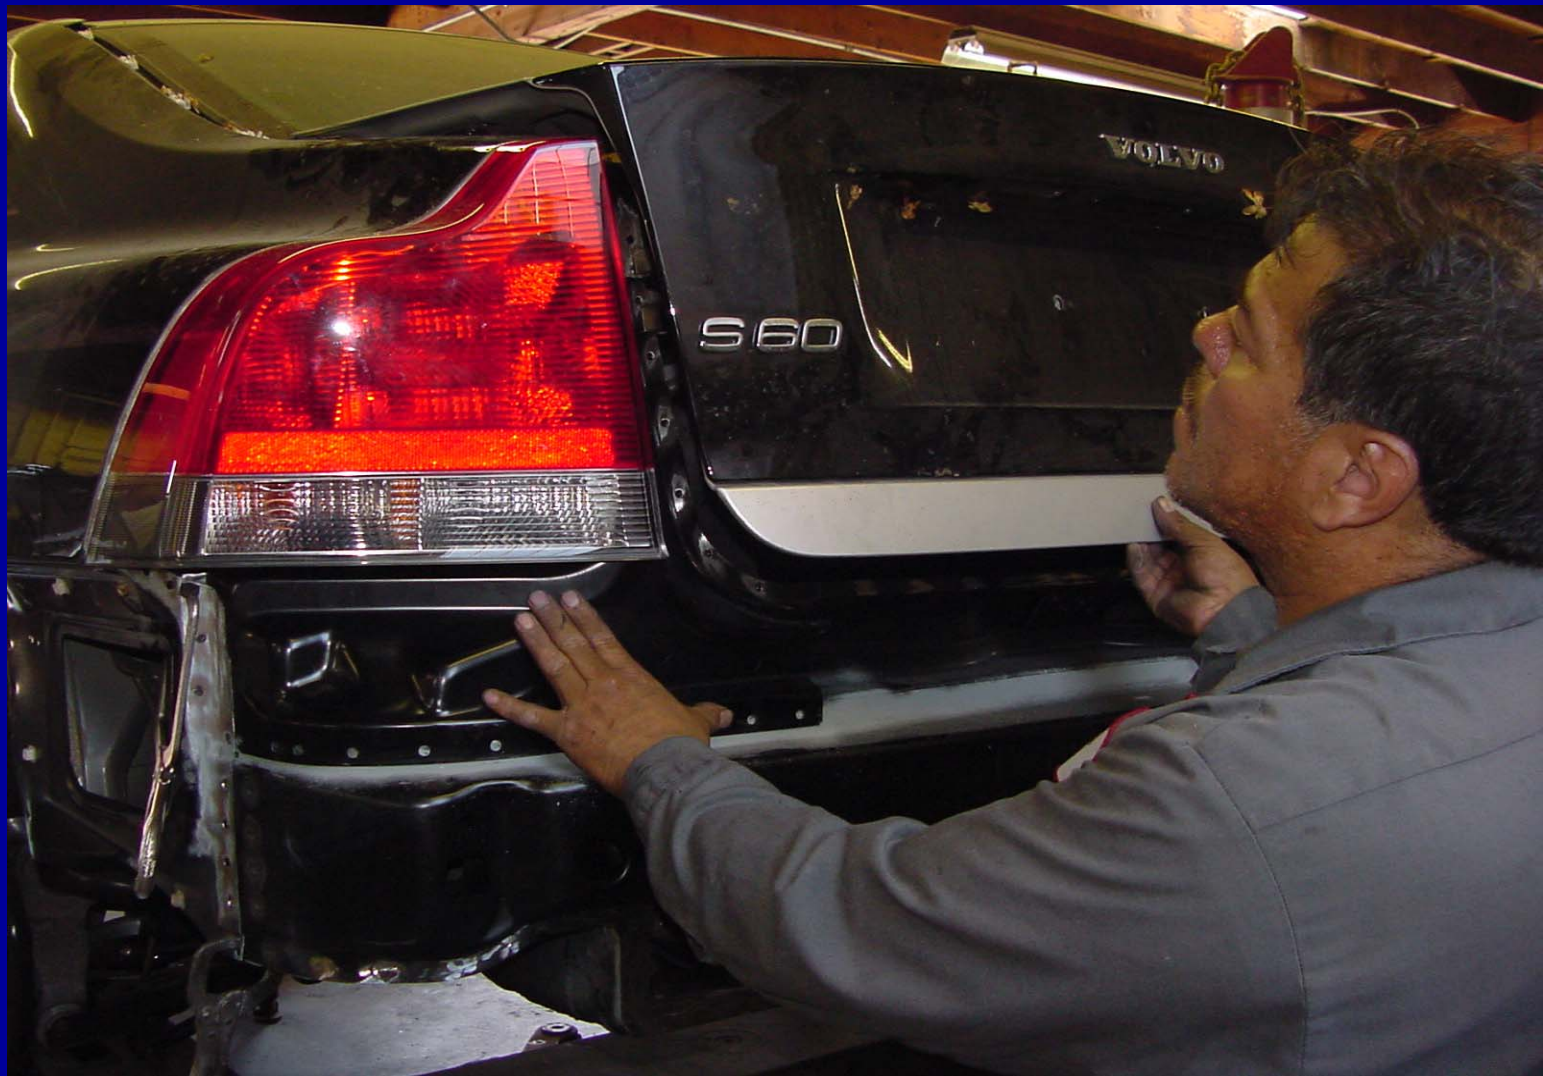
Install used deck lid & check all the gaps for proper dimensions.

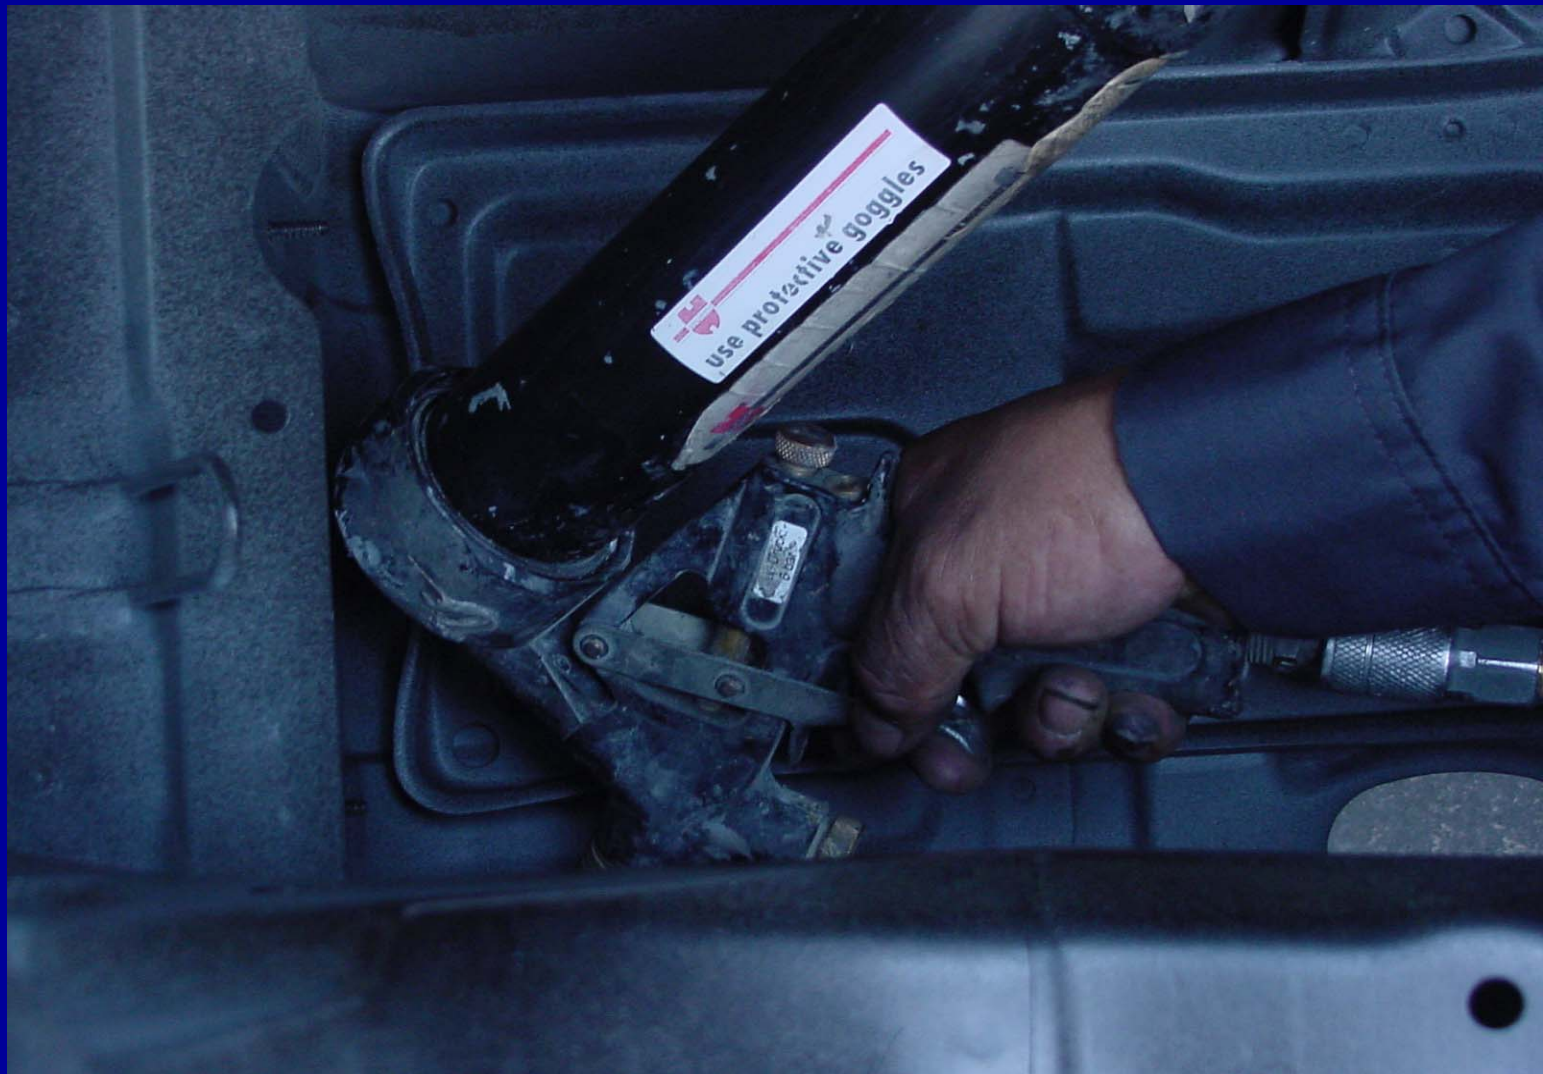
Apply sealant where the new rear body panel joins the quarter panels & trunk floor.

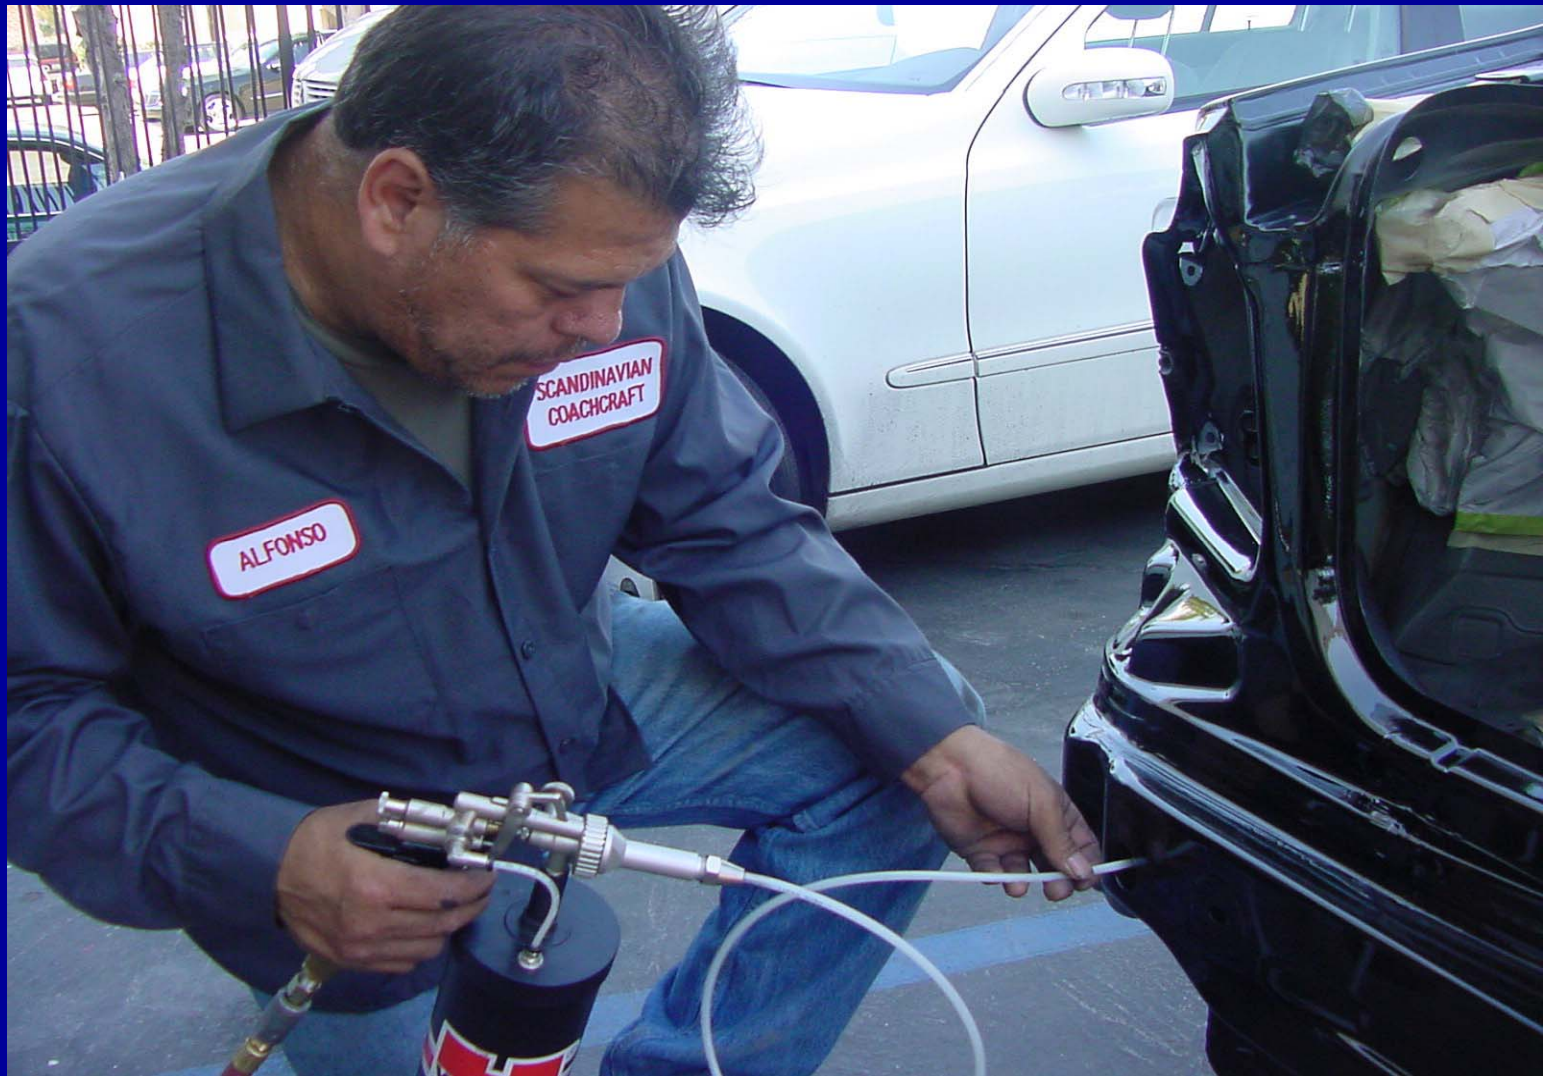
Apply cavity wax to the inner rear frame rails after the painting process.
